PROPERTY & TIMBER PEST REPORT

Property Address: 100 Main Street
BRISBANE
QLD 4000

Report Number: I999999

Inspection Date & Time: Wednesday 30 February 2012 11:30 AM

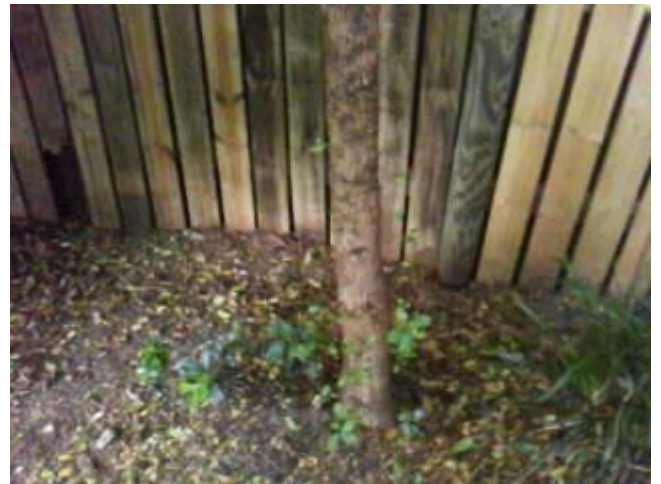
<u>Site Walls & Fence Defect/Observation</u>	
Structure	Boundary fence
Location	In General
Element	Palings
Defect/Observation	<p>Earth-wood contact</p> <p>Note: Untreated or non-durable timbers in direct contact with the ground/soil produce a ready food source for termites. Also, susceptible timbers used in a hazardous environment are prone to fungal decay.</p>
Extent	Widespread
Recommendation	<p>This defect falls within the category of "Timber Pest Activity". A further investigation by a Licensed Tradesperson is strongly recommended to determine the extent of remedial work required and associated costs. The above recommendation should be implemented without delay.</p>

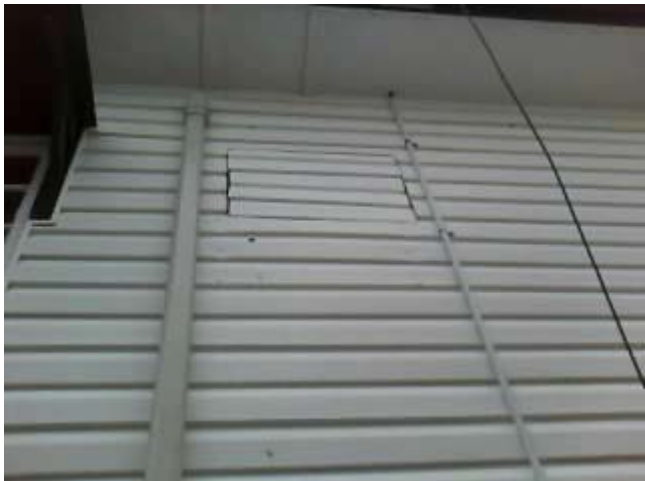
External Wall	External wall to the main building

Location	Southern side of the building	
Element	Cladding	
Element Type	Non-loadbearing	
Defect/Observation	Damaged	
Extent	Localised	
Recommendation	This defect falls within the category of Conditions Conducive to Structural Damage. A further investigation by a Licensed Builder is strongly recommended to determine the extent of remedial work required and associated costs. The above recommendation should be implemented without delay.

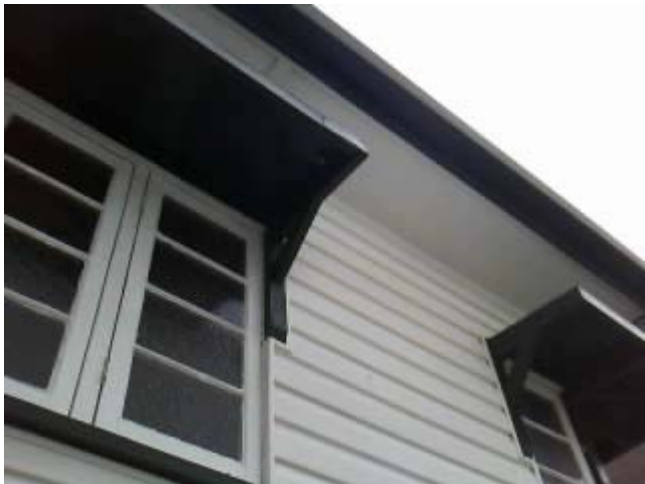
<u>External Window Defect/Observation</u>	
Location	Windows In general
Element	Awning
Defect/Observation	<p><u>Fungal Decay</u> Damage</p> <p><u>Sign of Fungal Decay</u></p> <p>Visible damage to timber</p> <p><u>Damage Status</u></p> <p>Decaying wood</p> <p>Note. Decaying wood contains sufficient moisture to retain its original shape. However, decay will most likely spread (unless sources of moisture are quickly removed).</p>
Extent	Localised
Recommendation	<p>This defect falls within the category of Conditions Conducive to Structural Damage & Timber Pest Activity. A further investigation by a Licensed Builder is strongly recommended to determine the extent of remedial work required and associated costs. The above recommendation should be implemented without delay.</p>

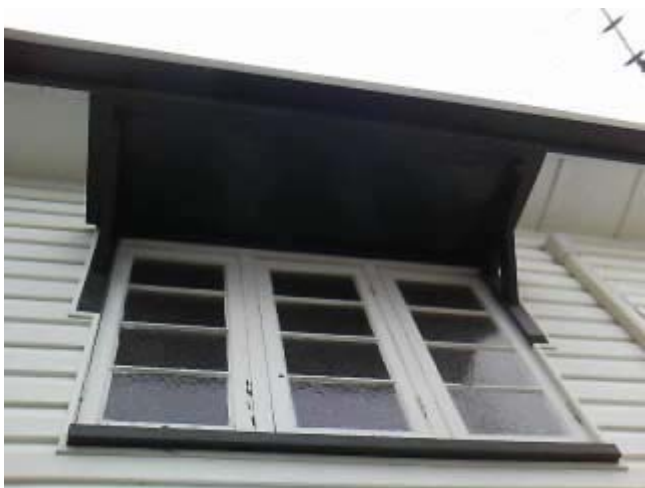
Location	Windows In general

Element	Awning	
Defect/Observation	Damaged	
Extent	Localised	
Recommendation	This defect falls within the category of Conditions Conducive to Structural Damage & Timber Pest Activity. A further investigation by a Licensed Builder is strongly recommended to determine the extent of remedial work required and associated costs. The above recommendation should be implemented without delay.

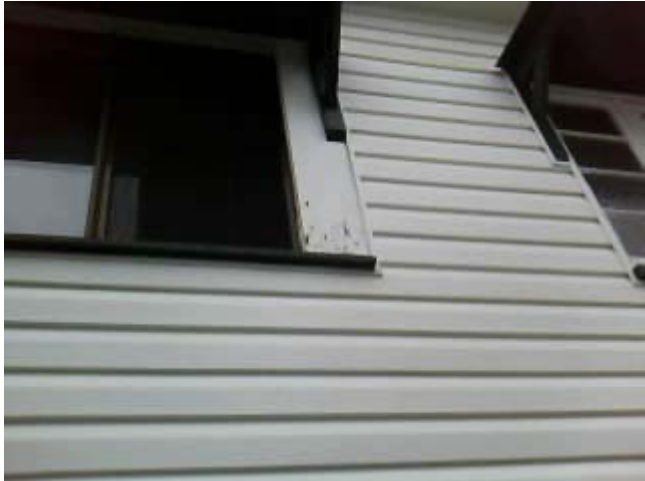
Location	Bedroom window South-western side of the building

Element	Frame	
Defect/Observation	<p><u>Fungal Decay</u> Damage <u>Sign of Fungal Decay</u> Misshapen timbers <u>Damage Status</u> Undetermined</p> <p>Note. Where the overall condition of the timber is undetermined, further inspections are strongly recommended. This may require monitoring of the timber over a period of time and include the assessment of conditions conducive to activity (e.g. in different weather conditions).</p>	
Extent	Localised	
Recommendation	<p>This defect falls within the category of Conditions Conducive to Structural Damage & Timber Pest Activity. A further investigation by a Licensed Builder is strongly recommended to determine the extent of remedial work required and associated costs. The above recommendation should be implemented without delay.</p>

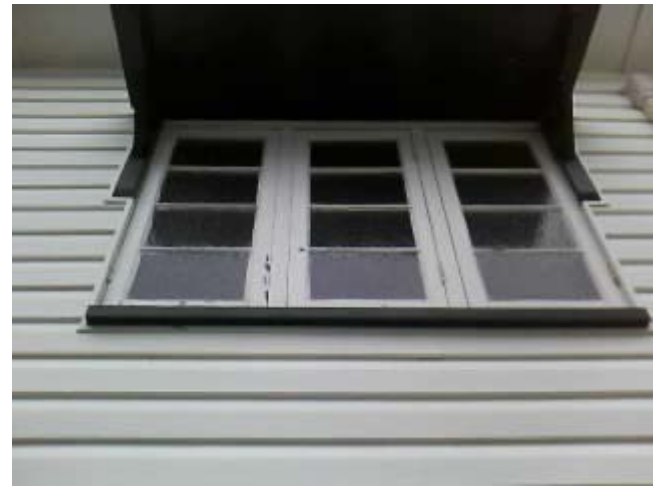
Location	Windows In general
Element	Frame
Defect/Observation	Flaking
Extent	Localised
Recommendation	Repainting is required.

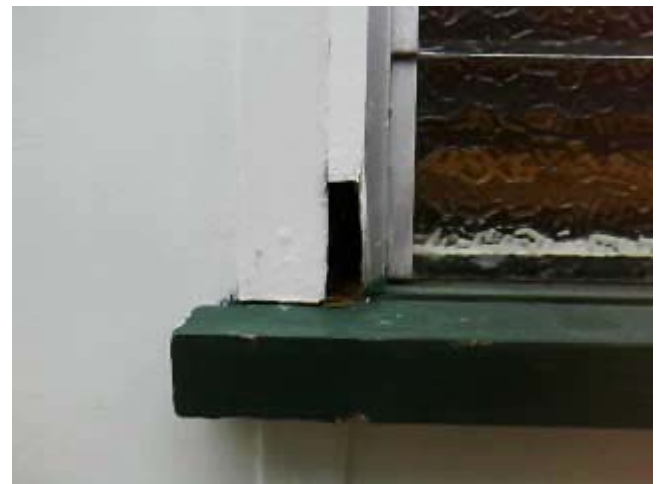
Location	Utility room window Southern side of the building
Element	Frame
Defect/Observation	<p><u>Fungal Decay</u> Damage <u>Sign of Fungal Decay</u> Visible damage to timber <u>Damage Status</u> Decaying wood</p> <p>Note. Decaying wood contains sufficient moisture to retain its original shape. However, decay will most likely spread (unless sources of moisture are quickly removed).</p>
Extent	Localised
Recommendation	<p>This defect falls within the category of Conditions Conducive to Structural Damage & Timber Pest Activity. A further investigation by a Licensed Builder is strongly recommended to determine the extent of remedial work required and associated costs. The above recommendation should be implemented without delay.</p>

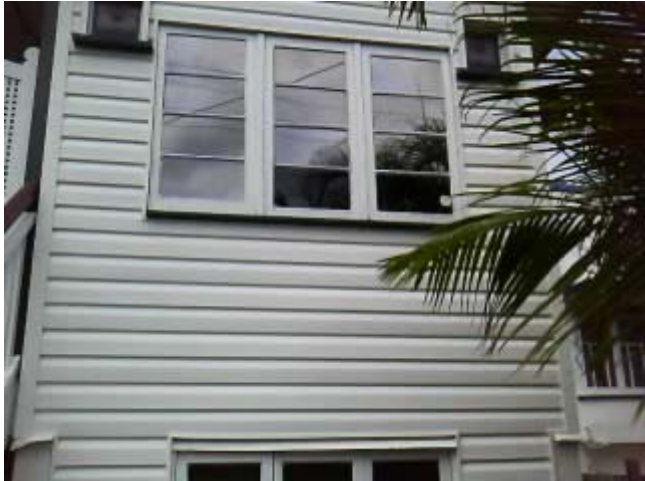
Location	Windows South-western side of the building

Element	Head flashing	
Defect/Observation	Missing	
Extent	Localised	
Recommendation	This defect falls within the category of Conditions Conducive to Structural Damage. A further investigation by a Licensed Builder is strongly recommended to determine the extent of remedial work required and associated costs. The above recommendation should be implemented without delay.

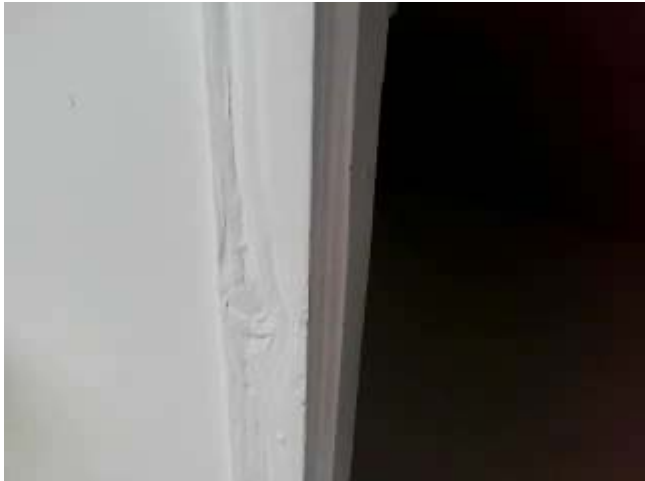
Doors	Utility room door

Location	Southern side of the building	
Element	Architrave	
Defect/Observation	<p>Fungal Decay Damage</p> <p><u>Sign of Fungal Decay</u></p> <p>Misshapen timbers</p> <p><u>Damage Status</u></p> <p>Decaying wood</p> <p>Note. Decaying wood contains sufficient moisture to retain its original shape. However, decay will most likely spread (unless sources of moisture are quickly removed).</p>	
Extent	Localised

Recommendation	This defect falls within the category of Conditions Conducive to Structural Damage & Timber Pest Activity. A further investigation by a Licensed Builder is strongly recommended to determine the extent of remedial work required and associated costs. The above recommendation should be implemented without delay.	
-----------------------	--	--

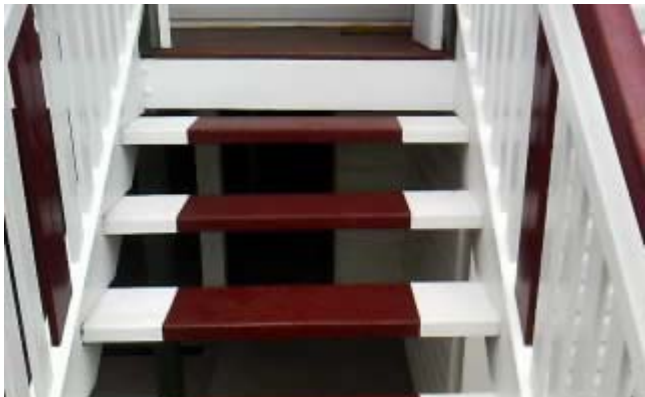
Location	Stairway Western side of the building

Element	Riser	
Defect/Observation	Risers not equal	
Extent	Widespread	
Recommendation	This matter requires urgent attention.

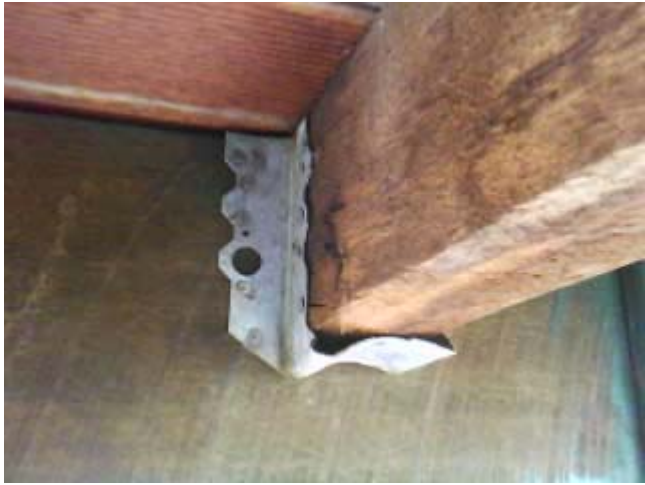
Location	Verandah Western side of the building

Element	Hangers , Fasteners	
Defect/Observation	Poorly secured	
Extent	Widespread	
Recommendation	This defect falls within the category of Conditions Conducive to Structural Damage. A further investigation by a Licensed Builder is strongly recommended to determine the extent of remedial work required and associated costs. The above recommendation should be implemented without delay.

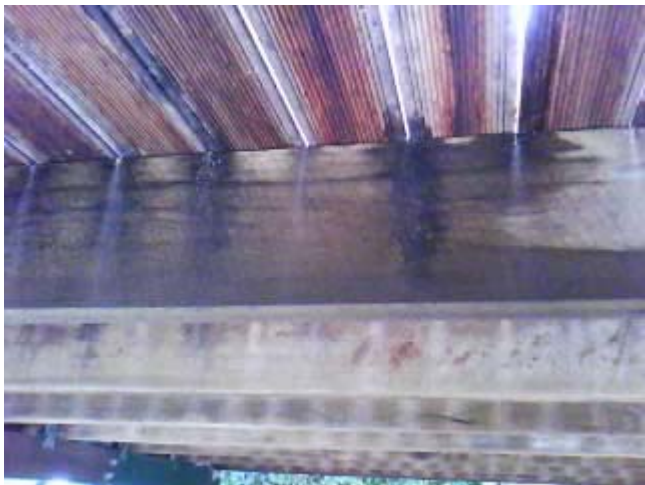
Location	Deck South-eastern side of the building

Element	Floor Frame	
Defect/Observation	Not sealed or flashed	
Extent	Widespread	
Recommendation	This defect falls within the category of Conditions Conducive to Structural Damage & Timber Pest Activity. A further investigation by a Licensed Builder is strongly recommended to determine the extent of remedial work required and associated costs. The above recommendation should be implemented as soon as possible.

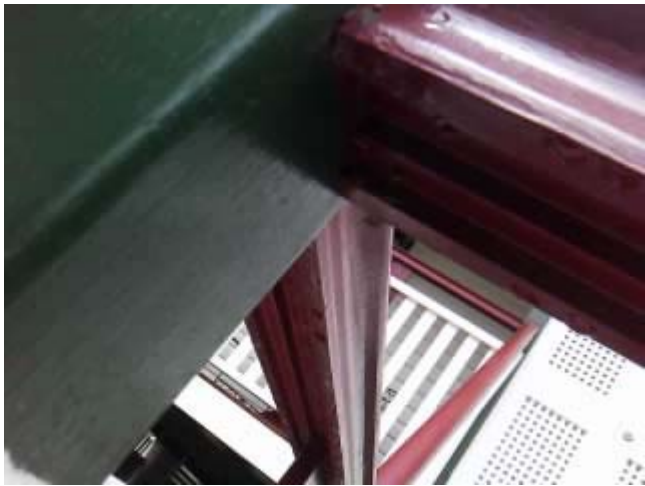
Location	Verandah, deck and stairs

Element	Handrails	
Defect/Observation	No safety lugs	
Extent	Widespread	
Recommendation	Replace the missing element.

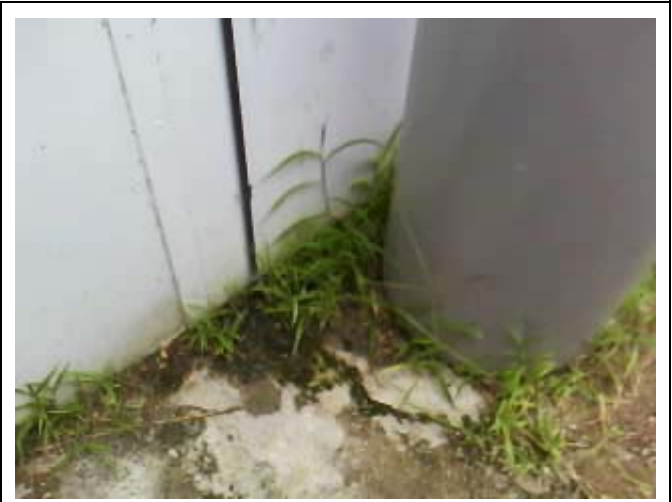
Location	North-eastern side of the building

Element	Water heater	
Defect/Obstruction	Discharging near footings. All AC or Water Heater drainage should be connected to a storm water drain, down pipe or directed well away from footings.	
Extent	Localised	
Recommendation	This defect falls within the category of Conditions Conducive to Structural Damage & Timber Pest Activity. A further investigation by a Licensed Plumber is strongly recommended to determine the extent of remedial work required and associated costs. The above recommendation should be implemented without delay.

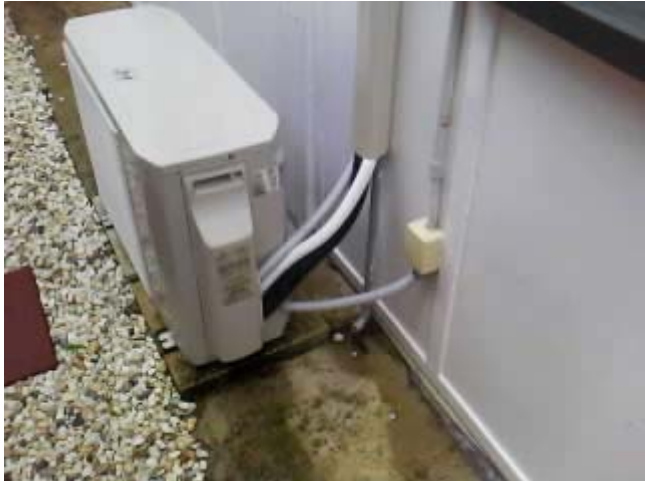
Location	Southern side of the building

Element	Air-conditioning unit	
Defect/Obstruction	Discharging near footings. All AC or Water Heater drainage should be connected to a storm water drain, down pipe or directed well away from footings.	
Extent	Localised	
Recommendation	This defect falls within the category of Conditions Conducive to Structural Damage & Timber Pest Activity. A further investigation by a Licensed Plumber is strongly recommended to determine the extent of remedial work required and associated costs. The above recommendation should be implemented without delay.

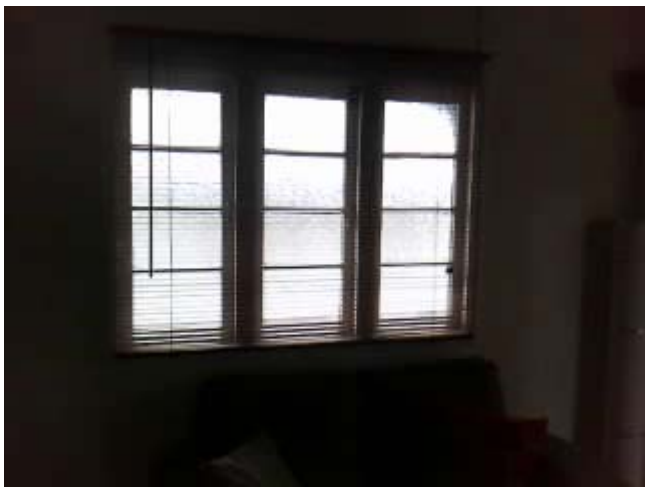
Window	Windows

Location	Living Room & bedroom 1	
Element	Frames	
Defect/Observation	Binding	
Extent	Localised	
Recommendation	Repairs or replacements are needed but the Consultant does not consider these to be urgent.

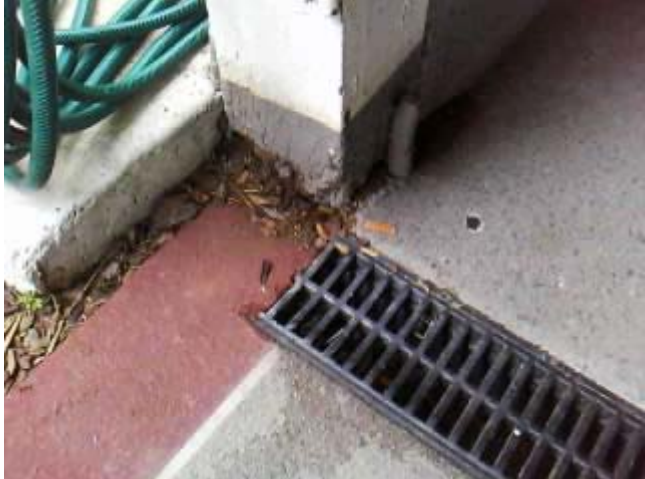
Area	Subfloor space to the main building

Location	In general	
Element	Stumps	
Defect/Observation	Earth/wood contact	
Extent	Undetermined	
Recommendation	This defect falls within the category of Conditions Conducive to Structural Damage & Timber Pest Activity. A further investigation by a Licensed Builder is strongly recommended to determine the extent of remedial work required and associated costs. The above recommendation should be implemented without delay.

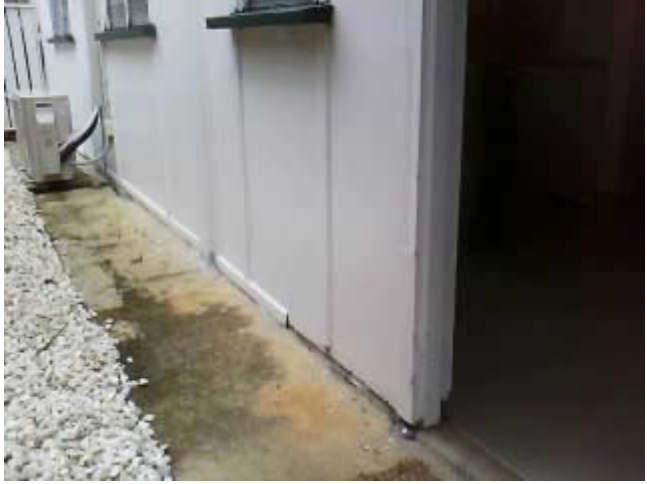
Area	Subfloor space to the main building

Location	South-western side of the building	
Element	Damp-proof course	
Defect/Observation	Damp masonry-wood contact Note: Untreated or non-durable timbers in direct contact with damp masonry are susceptible to timber pest activity and damage.	
Extent	Widespread	
Recommendation	This defect falls within the category of Conditions Conducive to Structural Damage & Timber Pest Activity. A further investigation by a Licensed Builder is strongly recommended to determine the extent of remedial work required and associated costs. The above recommendation should be implemented without delay.

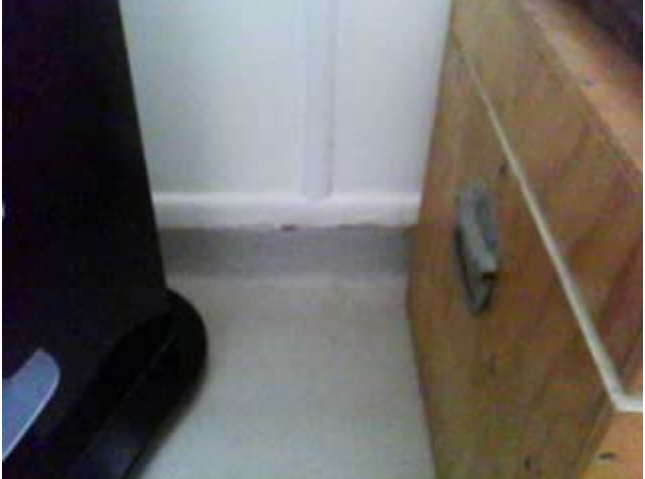
Area	Subfloor space to the main building, utility room

Location	Southern side of the building	
Element	Skirting	
Defect/Observation	<p><u>Fungal Decay</u> Activity</p> <p>Paint discolouration</p> <p>Note: Modify or remove conditions required for fungal growth, such as the presence of excessive moisture.</p>	
Extent	Undetermined	
Recommendation	<p>This defect falls within the category of Conditions Conducive to Structural Damage & Timber Pest Activity. A further investigation by a Licensed Builder is strongly recommended to determine the extent of remedial work required and associated costs. The above recommendation should be implemented without delay.</p>

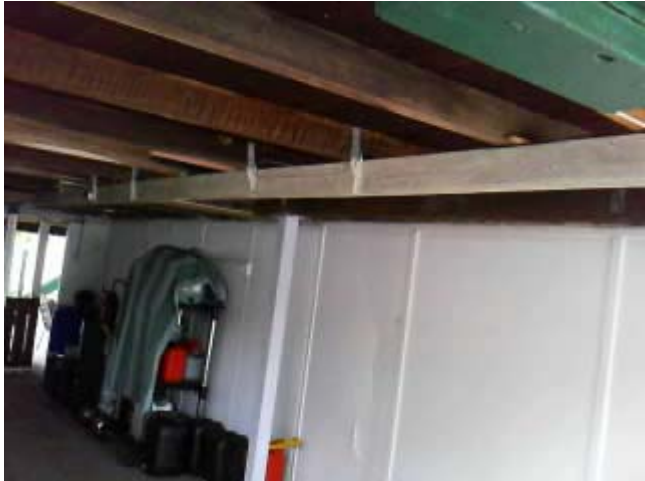
Area	Subfloor space to the main building

Location	North-western side of the building	
Element	Bearers	
Defect/Observation	over spanned	
Extent	Localised	
Recommendation	This defect falls within the category of Conditions Conducive to Structural Damage. A further investigation by a Licensed Builder is strongly recommended to determine the extent of remedial work required and associated costs. The above recommendation should be implemented without delay.

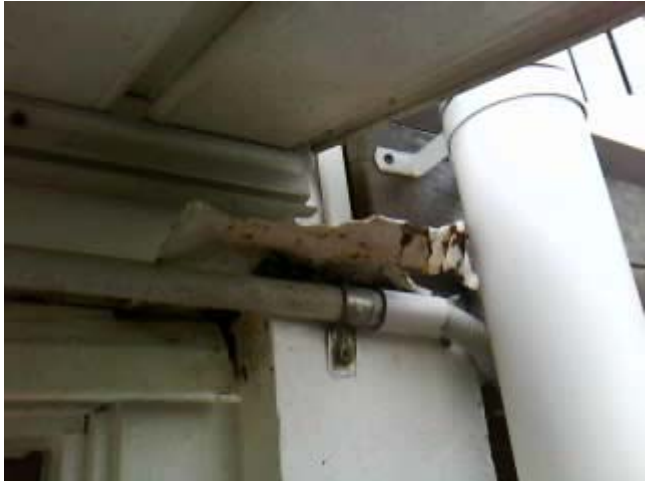
Area	Subfloor space to the main building

Location	In general	
Element	Termite capping	
Defect/Observation	<p>Bridging</p> <p>Note: 'Bridging' is the spanning of a termite barrier or inspection zone so that subterranean termites are provided with passage over or around that barrier. Australian Standard AS 3660 recognises that barriers shall not be bridged by structures attached to the main building e.g. steps, verandahs, access ramps, claddings, carports, or trellises unless alternative barriers are used to prevent access by termites to the structure.</p>	
Extent	Widespread	
Recommendation	<p>This defect falls within the category of Conditions Conducive to Structural Damage & Timber Pest Activity. A further investigation by a Licensed Builder is strongly recommended to determine the extent of remedial work required and associated costs. The above recommendation should be implemented without delay.</p>
