Australian Building Inspection Services Pty. Ltd.

Standard Property Inspection and Timber Pest Detection Report

Property Inspected: 12 Low Street Brisbane QLD 4000

ID: I09999

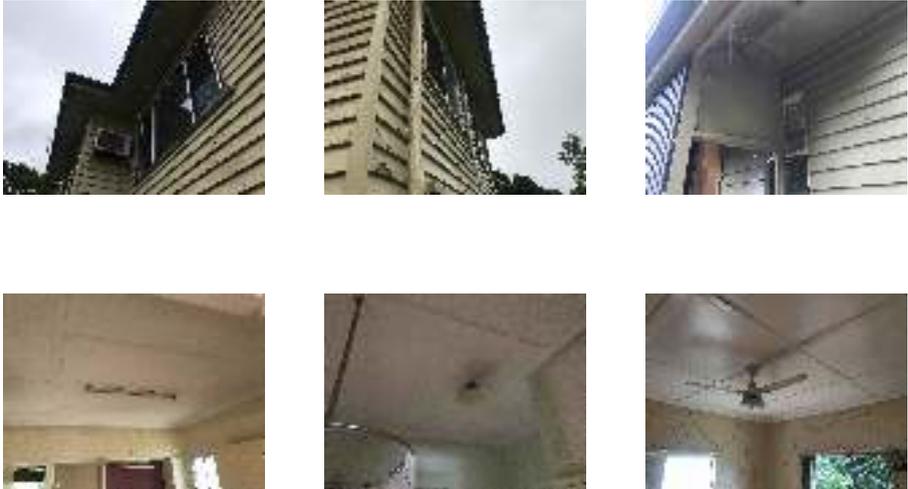
Serious Safety Hazard	
Description	Asbestos risk. Drilling, cutting or removing sheeting or products containing Asbestos is a high risk to human health. Likewise, damaged or friable asbestos-cement products may release asbestos fibres. You should seek advice from a qualified asbestos spec
Location	Main House In General
Recommendation	This condition is considered dangerous. A further investigation by a Tradesperson is strongly recommended to determine the extent of remedial work required. This recommendation should be implemented as a matter of urgency. Immediate action must be taken to ensure that anyone entering the area is warned of this hazard.
Photos

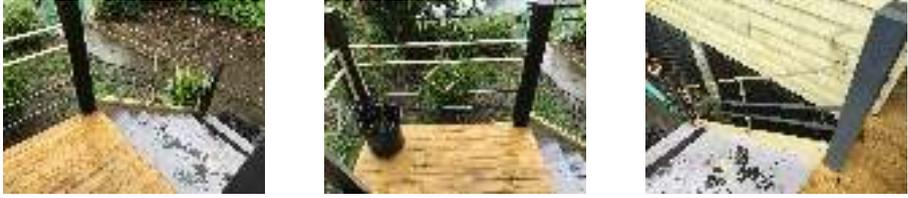
Serious Safety Hazard	
Description	The platform or stair is more than 1 meter from the ground and the balustrade is less than 1 meter in height.
Location	External Stairs At The Front Of The Property Eastern Side Of The Property
Recommendation	This condition is considered dangerous. A further investigation by a Carpenter is strongly recommended to determine the extent of remedial work required. This recommendation should be implemented without delay. Immediate

action must be taken to ensure that anyone entering the area is warned of this hazard.
Photos

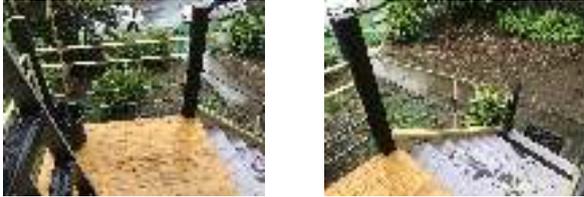
Serious Safety Hazard	
Description	The platform or stair is more than 1 meter from the ground and has gaps greater than 125mm.
Location	External Stairs At The Front Of The Property Eastern Side Of The Property
Recommendation	This condition is considered dangerous. A further investigation by a Carpenter is strongly recommended to determine the extent of remedial work required. This recommendation should be implemented without delay. Immediate action must be taken to ensure that anyone entering the area is warned of this hazard.
Photos

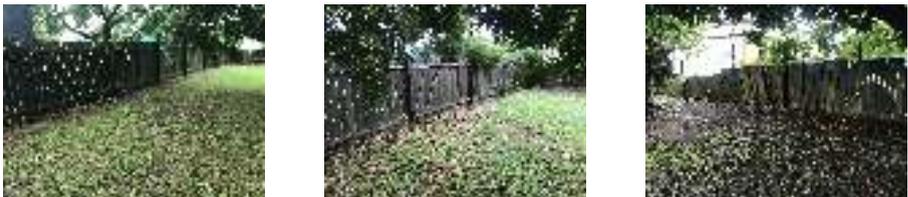
Yard Timber Pest Defect	
Which Structure	Boundary fence
Location	In General
Element	Palings
Defect	Earth-wood contact Note: Timber in direct contact with the ground/soil produce a ready food source for termites. Also, susceptible timbers used in a hazardous environment are prone to fungal decay.
Defect Category	Condition Conducive To Timber Pests
Extent	Widespread
Photos

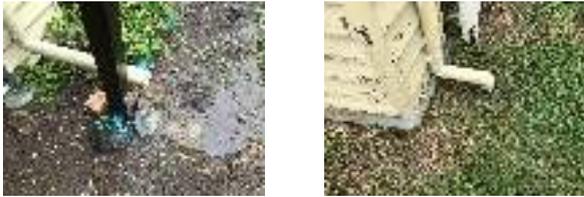
Which Building	Main Building
-----------------------	---------------

Location	At the front
Element	Downpipe
Defect	Downpipe(s) not connected to stormwater drainage or away from footings. If moisture is allowed to accumulate at the base of walls and near footings it creates a condition that supports timber pest activity and can effect the stability of foundations soils over time.
Defect Category	Conditions Conducive to Timber Pest Activity
Extent	Widespread
Photos

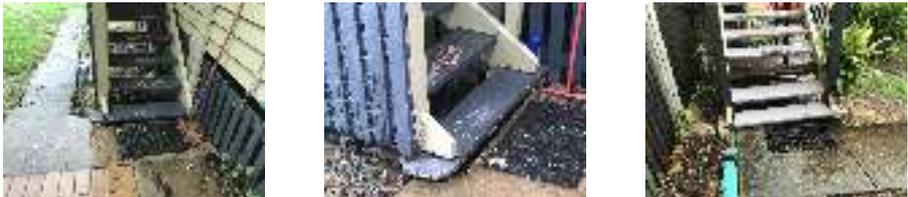
Exterior Timber Pest Defect	
Which Stairs	Stairway
Location	In general At the back At the front
Element	Stringer Newel Post Tread
Defect	Earth-wood contact Note: Timber in direct contact with the ground/soil produce a ready food source for termites. Also, susceptible timbers used in a hazardous environment are prone to fungal decay.
Defect Category	Condition Conducive To Timber Pests
Extent	Localised
Photos

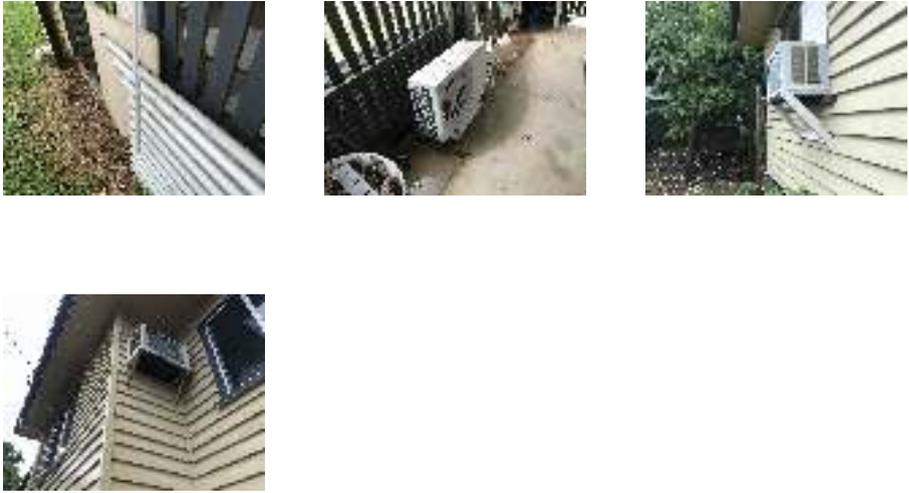
Location	In general
Defect Element	Air-conditioning unit
Defect	AC unit drains not connected to storm water drainage or away from footings. Water flows from AC unit drains when they are running. If this moisture is allowed to accumulate at the base of walls and near footings it creates a condition that supports timber pest activity and can effect the stability of foundations soils over time.
Defect Category	Condition Conducive to Timber Pest Activity
Extent	Widespread
Photos

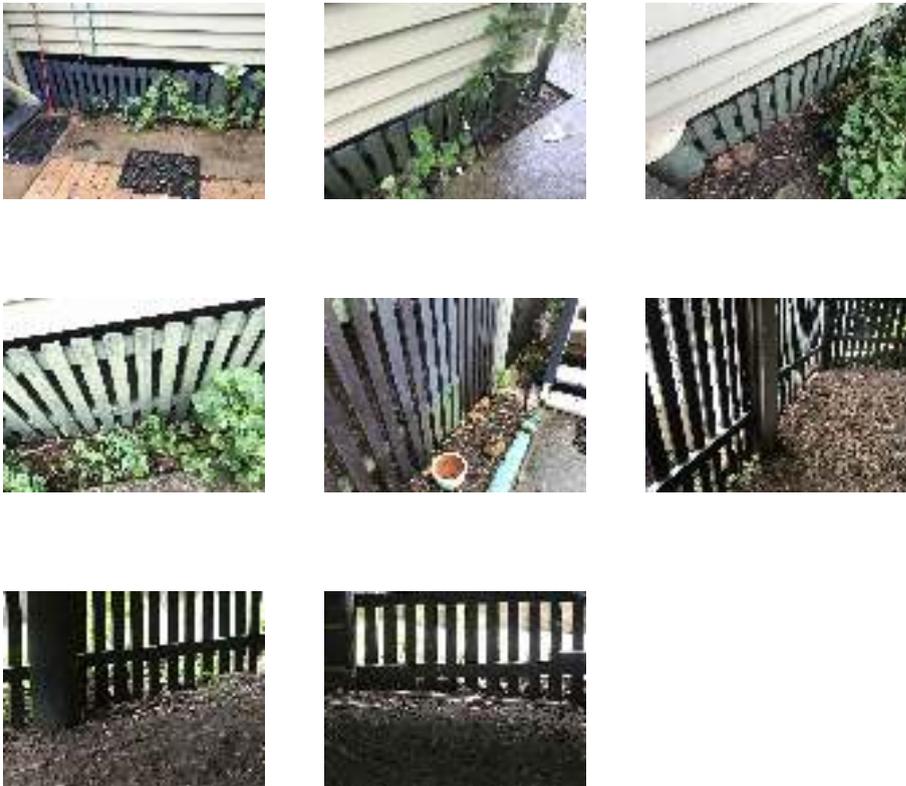
Subfloor Timber Pest Defect	
Which Subfloor	Subfloor space to the main building
Area Affected	In general
Element	Sub-floor battens and associated framing
Defect	Earth-wood contact Note: Timber in direct contact with the ground/soil produce a ready food source for termites. Also, susceptible timbers used in a hazardous environment are prone to fungal decay.
Defect Category	Condition Conducive To Timber Pests
Extent	Widespread
Photos

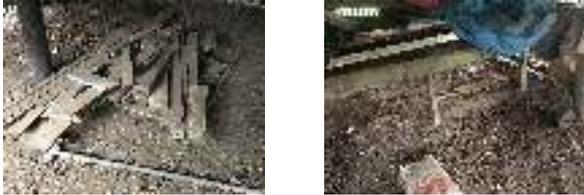
Subfloor Timber Pest Defect	
Which Subfloor	Subfloor space to the main building
Area Affected	In general
Element	Subfloor space
Defect	Timber in contact with the ground. Note: Ground contact will raise the moisture content of the timber creating conditions conducive to fungal

decay, termites or other timber pests.
Defect Category	Condition Conducive To Timber Pests
Extent	Localised
Photos

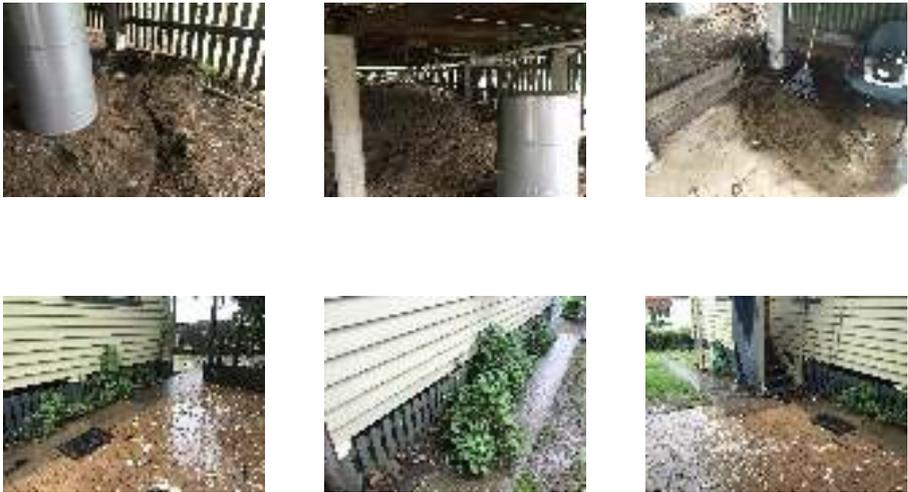
Subfloor Timber Pest Defect	
Which Subfloor	Subfloor space to the main building
Area Affected	In general
Element	Subfloor space
Defect	Excessive moisture
Defect Category	Condition Conducive To Timber Pests
Extent	Localised
Photos

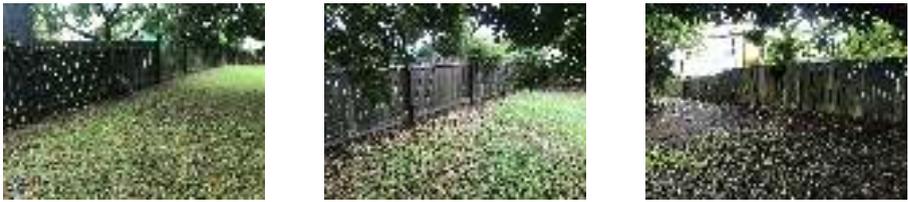
Yard Walls and Fences Defect	
Which Structure	Boundary fence
Location	In General
Element	Palings
Defect	Earth-wood contact Note: Timber in direct contact with the ground/soil produce a ready food source for termites. Also, susceptible timbers used in a hazardous environment are prone to fungal decay.
Defect Category	Conditions Conducive to Timber Pests
Severity	Minor
Extent	Widespread
Recommendation	Action is required to remove this condition in order to prevent Timber Pest activity occurring. A further investigation by a Fencing specialist is recommended to determine the extent of work required and associated costs.
Photos

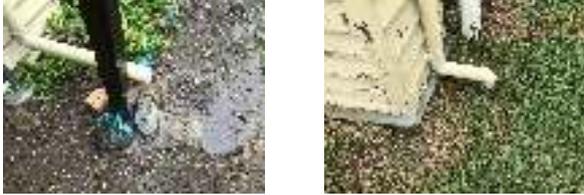
Rainwater Good Defect	
Which Building	Main Building
Location	At the front
Element	Downpipe
Defect	Downpipe(s) not connected to stormwater drainage or away from footings. If moisture is allowed to accumulate at the base of walls and near footings it creates a condition that supports timber pest activity and can effect the stability of foundations soils over time.
Defect Category	Conditions Conducive to both Timber Pest Activity and Structural Damage
Severity	Moderate - Repairs may involve significant expenditure
Extent	Widespread

Recommendation	Action is required to remove conditions conducive to both timber pest activity and structural damage. A further investigation by a drainer is also recommended to determine the extent of work required and associated costs.
Photos

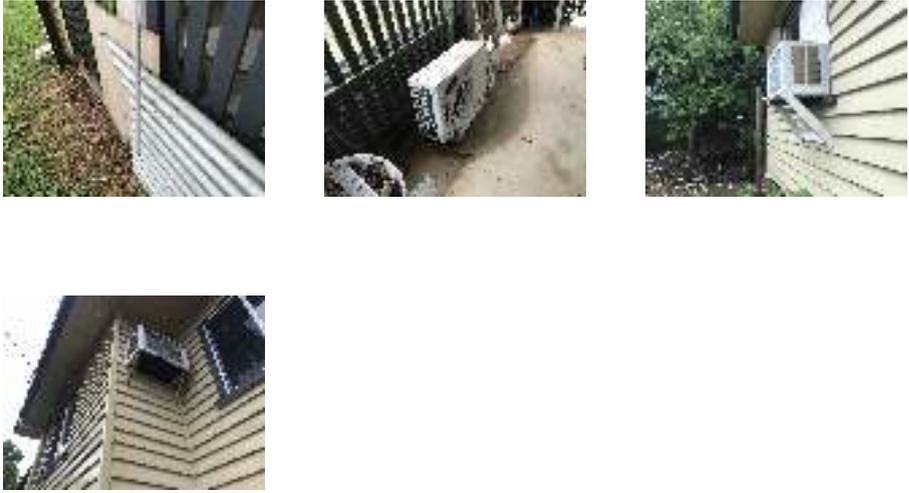
Other Exterior Secondary & Finishing Elements Defect	
Location	In general
Defect Element	Air-conditioning unit
Defect	AC unit drains not connected to storm water drainage or away from footings. Water flows from AC unit drains when they are running. If this moisture is allowed to accumulate at the base of walls and near footings it creates a condition that supports timber pest activity and can effect the stability of foundations soils over time.
Defect Category	Conditions Conducive to both Timber Pest Activity and Structural Damage
Severity	Minor
Extent	Widespread

Recommendation	Action is required to remove conditions conducive to both timber pest activity and structural damage.
Photos

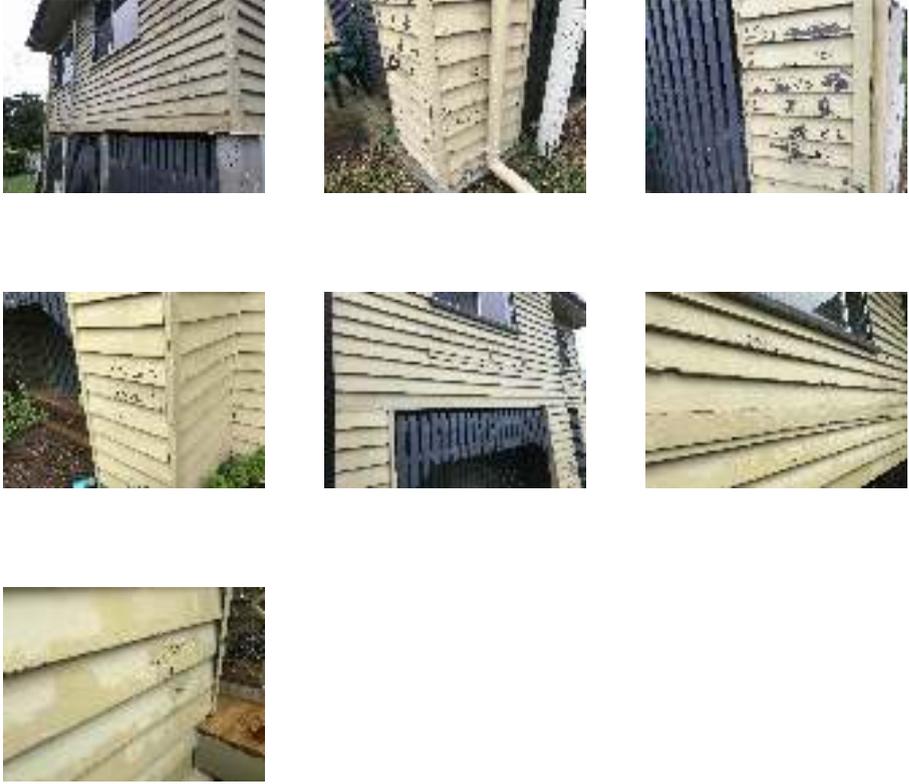
Other Exterior Secondary & Finishing Elements Defect	
Location	In general
Defect Element	Paintwork
Defect	Poorly painted

Requires Painting
Defect Category	Defect in Secondary or Finishing Element
Severity	Minor
Extent	Widespread
Recommendation	Paint
Photos

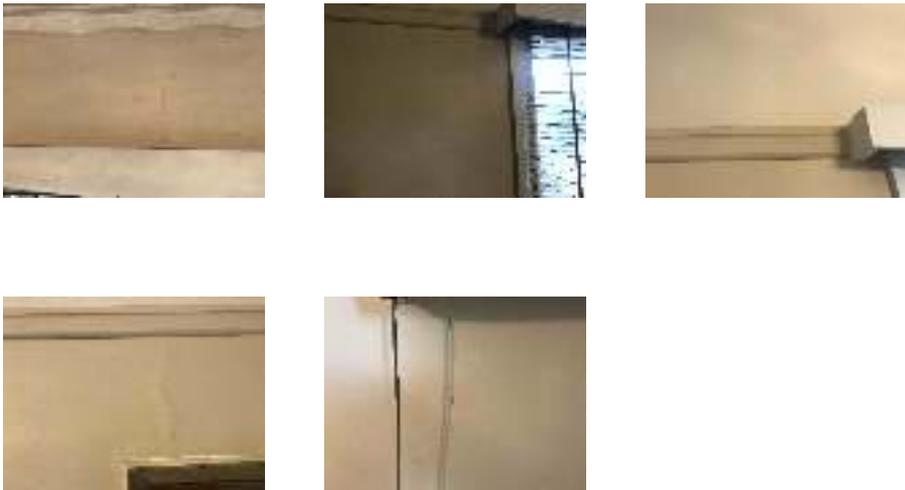
Interior Walls Defect	
Location	In general
Element	Wall plasterboard
Defect	Cracked
Defect Category	Defect in Secondary or Finishing Element
Severity	Minor
Extent	Localised
Recommendation	Ongoing maintenance to address normal wear & tear associated with the age and type of element should be carried out.
Photos

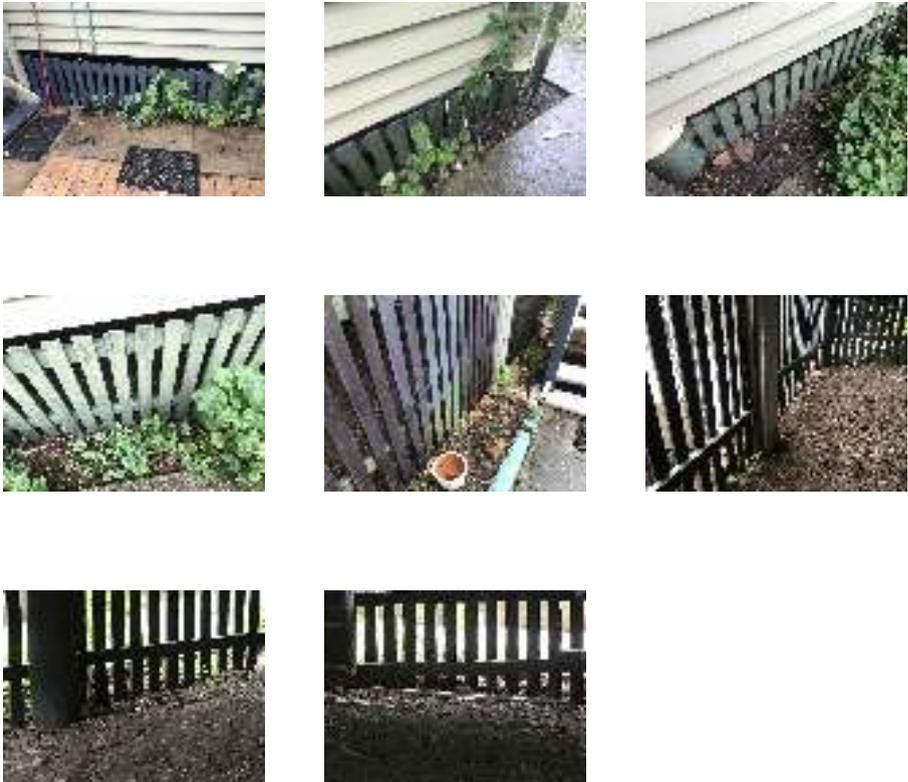
Subfloor Defect	
Which Subfloor	Subfloor space to the main building
Area Affected	In general

Element	Sub-floor battens and associated framing
Defect	Earth-wood contact Note: Timber in direct contact with the ground/soil produce a ready food source for termites. Also, susceptible timbers used in a hazardous environment are prone to fungal decay.
Defect Category	Condition Conducive To Timber Pests
Severity	Minor
Extent	Widespread
Recommendation	Action is required to remove this condition in order to prevent Timber Pest activity occurring. A further investigation by a Builder and a Pest Controller (Timber Pest Specialist) is recommended to determine the extent of work required and associated costs.
Photos

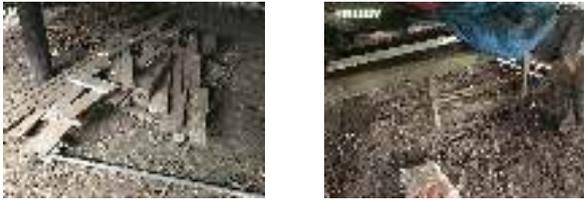
Subfloor Defect	
Which Subfloor	Subfloor space to the main building
Area Affected	In general
Element	Subfloor space
Defect	Timber in contact with the ground. Note: Ground contact will raise the moisture content of the timber creating conditions conducive to fungal decay, termites or other timber pests.

Defect Category	Condition Conducive To Timber Pests
Severity	Minor
Extent	Localised
Recommendation	Action is required to remove this condition in order to prevent damage to a Structural Element and or Timber Pest activity occurring.
Photos

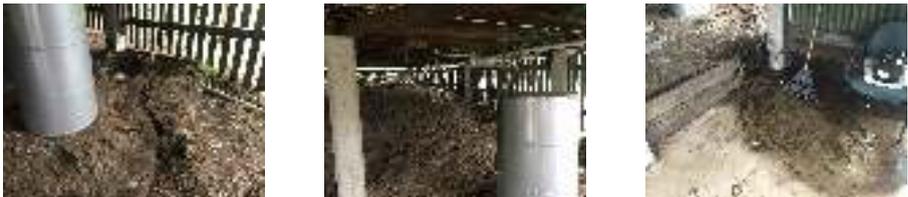
Subfloor Defect	
Which Subfloor	Subfloor space to the main building
Area Affected	In general
Element	Subfloor space
Defect	Excessive moisture
Defect Category	Condition Conducive To Timber Pests
Severity	Minor
Extent	Localised
Recommendation	Action is required to remove this condition in order to prevent damage to a Structural Element and or Timber Pest activity occurring. A further investigation by a Builder and a Pest Controller (Timber Pest Specialist) is recommended to determine the extent of work required and associated costs.
Photos
