Australian Building Inspection Services Pty. Ltd.

Standard Property Inspection and Timber Pest Detection Report

Property Inspected: 10 High Street Street Newtown QLD 4848

ID: I838130

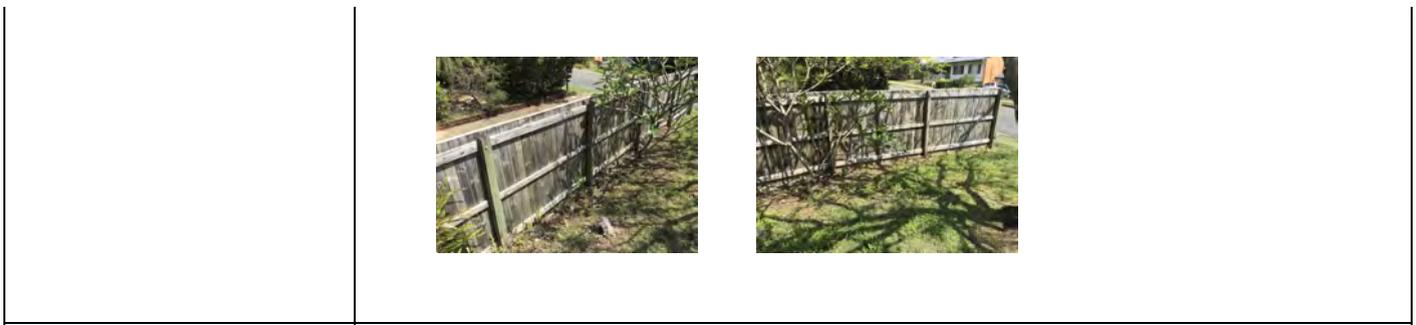
Conditions Conducive To Timber Pests - Yard	
Which Structure	Boundary fence
Location	Eastern Side Of The Property
Element	Palings
Defect	Earth-wood contact Note: Timber in direct contact with the ground/soil produce a ready food source for termites. Also, susceptible timbers used in a hazardous environment are prone to fungal decay.
Extent	Widespread
Photos

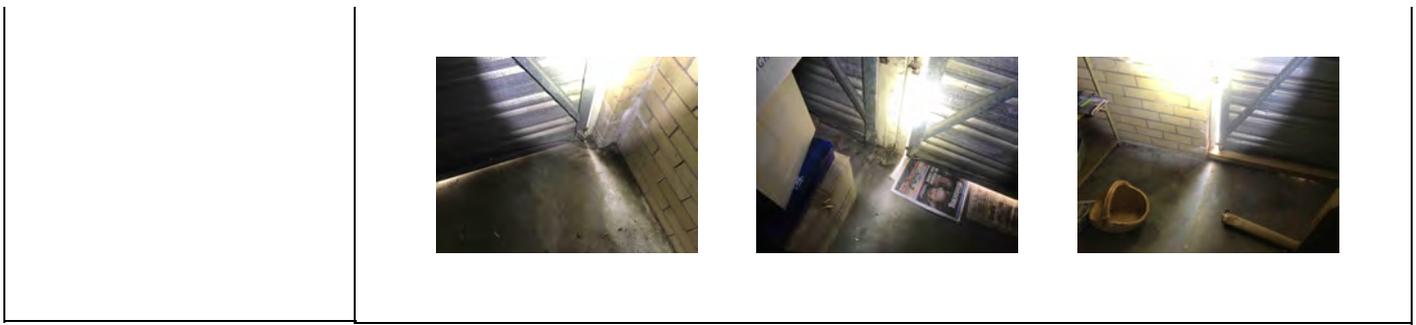
Conditions Conducive to Timber Pests - Exterior	
Which Door	Garage door
Location	At the front
Element	Jamb
Defect	Timber in contact with masonry that is not isolated from ground moisture. (e.g. no damp proof course to prevent rising damp). Note: Damp masonry will raise the moisture content of the timber it is in contact with, creating conditions conducive to fungal decay, termites or other timber pests.
Extent	Localised
Photos

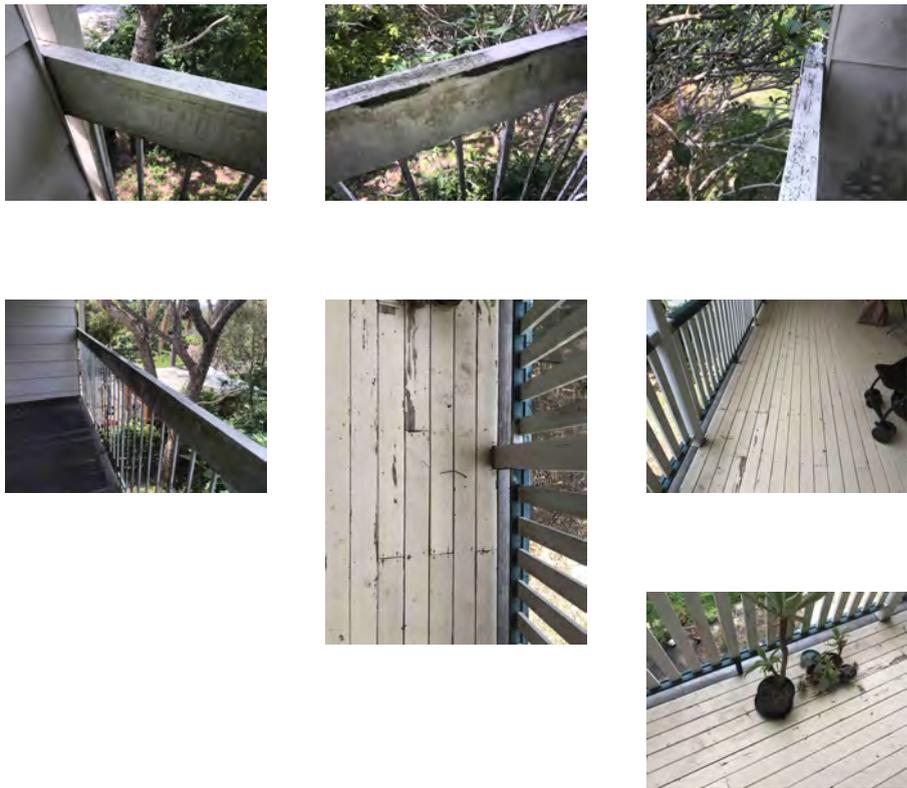
Defect	<p>Fungal Decay Activity:</p> <p>Indicated by paint discolouration.</p> <p>Indicated by darkening of timber or tide marks.</p> <p>Indicated by visible damage to timber.</p>
---------------	--

Extent	Localised
Photos

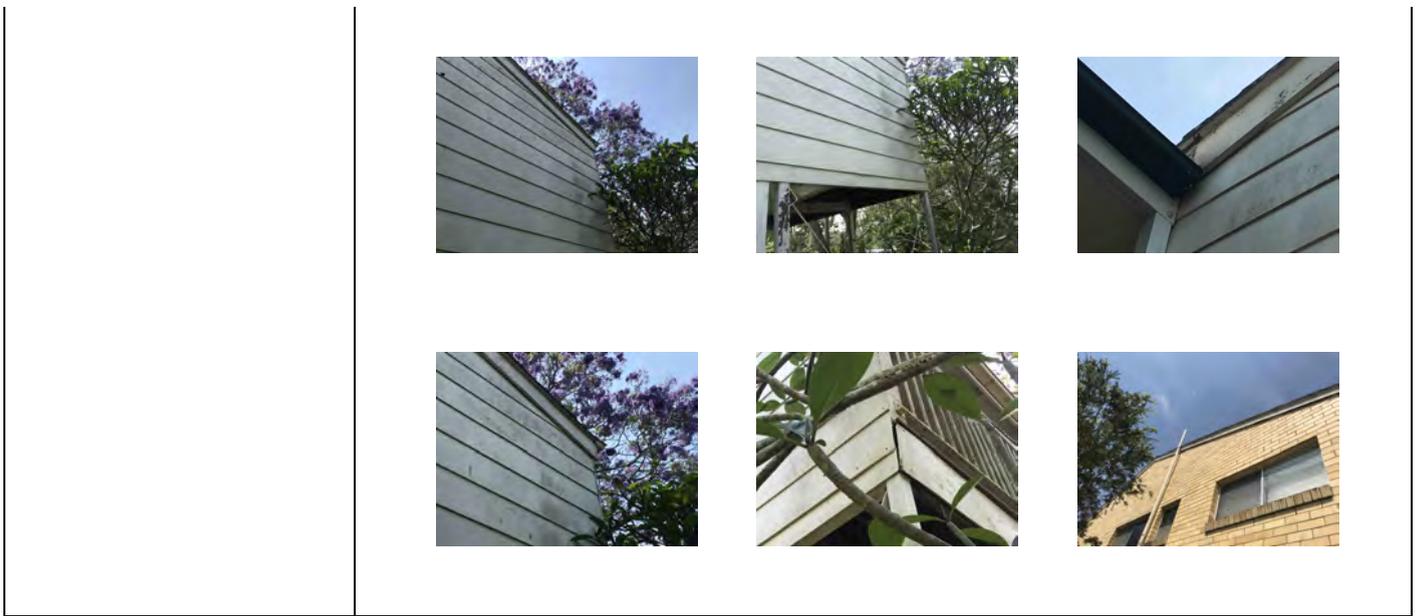
Timber Pest Activity - Exterior	
Location	In general
Defect Element	Barge board External joinery Cladding
Defect	<p>Fungal Decay Activity:</p> <p>Indicated by paint discolouration.</p> <p>Indicated by visible damage to timber.</p> <p>Indicated by darkening of timber or tide marks.</p>
Extent	The extent was undetermined
Photos

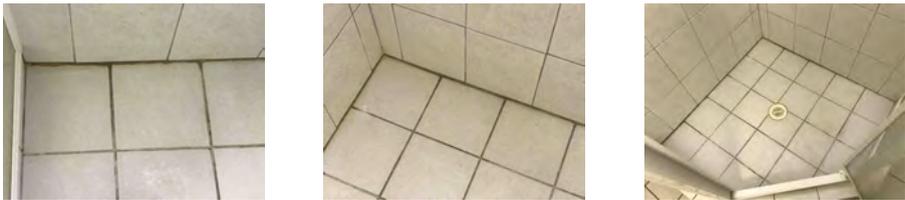
Condition Conducive To Timber Pests - Interior	
Which Fixture	Shower
Location	Ground floor Bathroom
Element	Sealant to shower base perimeter
Defect	<p>Poorly Sealed</p> <p>Maintaining the sealant to splash backs, shower bases, behind tap flanges and the like reduces the pressure on the underlying waterproofing.</p>

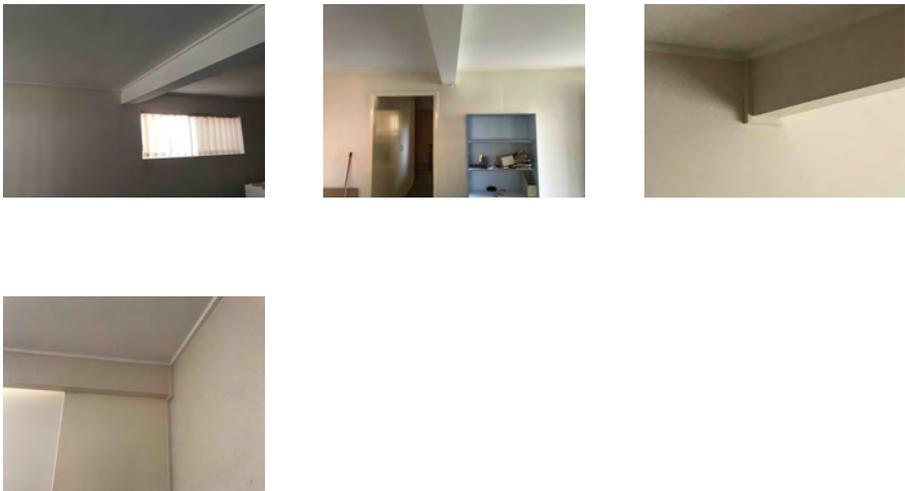
Condition Conducive To Timber Pests - Subfloor

Which Subfloor	Subfloor space to the main building
Area Affected	In general
Element	Termite capping
Defect	<p>Bridged by infill wall structures.</p> <p>Note: "Bridging" is the spanning of a termite barrier or inspection zone so that subterranean termites are provided with passage over or around that barrier in a manner that is not visible to an inspection process.</p> <p>Australian Standard AS 3660 recognises that barriers shall not be bridged by structures attached to the main building e.g. steps, verandahs, access ramps, claddings, carports, or trellises unless alternative barriers are used to prevent access by termites to the structure.</p>
Extent	Widespread
Photos

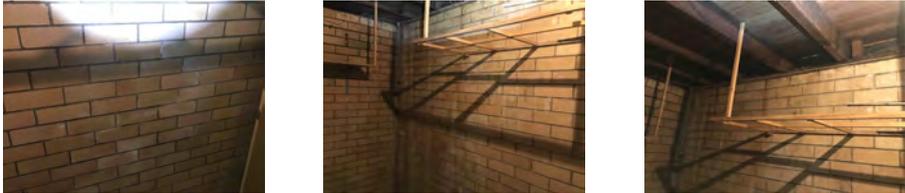
Condition Conducive to Timber Pests - Subfloor

Which Subfloor	Subfloor space to the main building
Area Affected	At the front
Element	Walls
Defect	Moisture penetration consistent with defective or damaged "tanking" (a system of waterproofing to a wall structure partially or fully below ground level)
Extent	Widespread
Photos

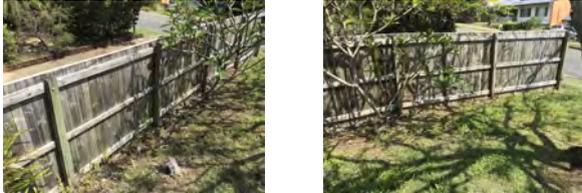
Yard Walls and Fences Defect	
Which Structure	Boundary fence
Location	Eastern Side Of The Property
Element	Palings
Defect	Earth-wood contact Note: Timber in direct contact with the ground/soil produce a ready food source for termites. Also, susceptible timbers used in a hazardous environment are prone to fungal decay.

Defect Category	Conditions Conducive to Timber Pests
Severity	Minor
Extent	Widespread
Recommendation	Action is required to remove this condition in order to prevent Timber Pest activity occurring. A further investigation by a Fencing specialist is recommended to determine the extent of work required and associated costs.
Photos

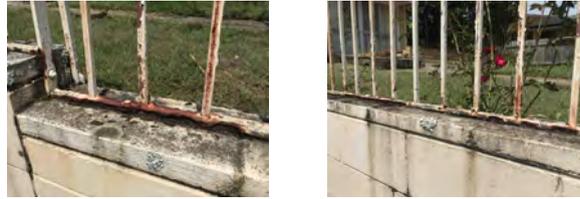
Which Structure	Retaining wall Fence
Location	South-Western Side Of The Property
Element	Balustrade
Defect	Corrosion
Defect Category	Defect in Secondary or Finishing Element
Severity	Major - Repairs are likely to involve significant expenditure
Extent	Localised
Recommendation	A further investigation is recommended by the following trades to determine the extent of work required and associated costs. Licenced Tradesperson

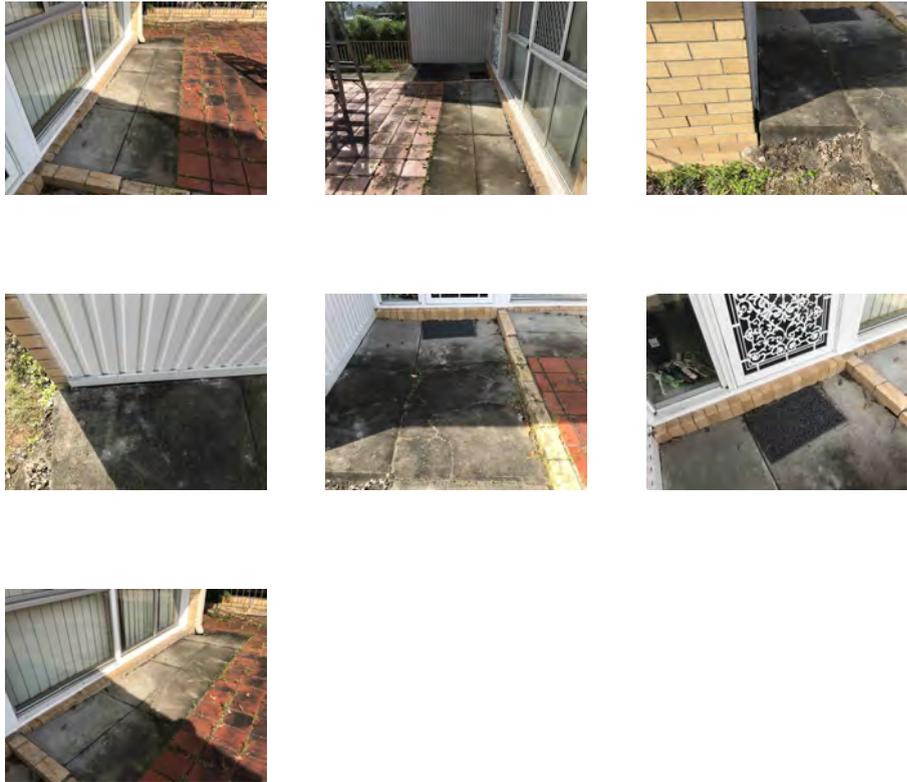
Grounds Defect	
Which Area	Patio Paved Area
Location	At The Front Of The Property
Element	Concrete Surface drainage
Defect	Cracking and movement Defects: Concrete cracking due to subsidence
Defect Category	Structural Defect

Severity	Major - Repairs are likely to involve significant expenditure
Extent	The extent was undetermined
Recommendation	Action is required to repair the damage to this element to restore structural integrity. A further investigation by the following trades is recommended to determine the extent of work required and associated costs. Geotechnical Engineer
Photos

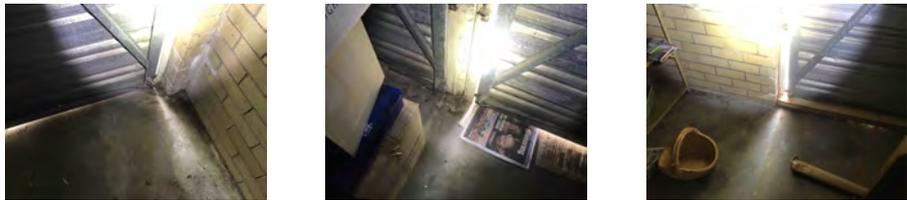
Exterior Door Defect	
Which Door	Garage door
Location	At the front
Element	Jamb
Defect	Timber in contact with masonry that is not isolated from ground moisture. (e.g. no damp proof course to prevent rising damp). Note: Damp masonry will raise the moisture content of the timber it is in contact with, creating conditions conducive to fungal decay, termites or other timber pests.
Defect Category	Condition Conducive to both Timber Pest Activity and Structural Damage
Severity	Minor
Extent	Localised
Recommendation	Action is required to remove this condition in order to prevent Timber Pest activity occurring. A further investigation by a builder is recommended to determine the extent of work required and associated costs.

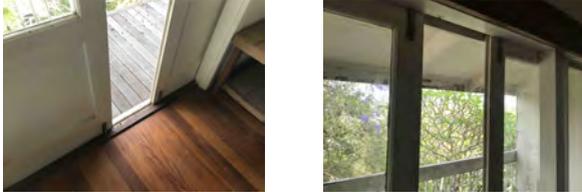
Exterior Door Defect	
Which Door	Patio door Sliding glass door
Location	At the back
Element	Door Sliding door rollers
Defect	Not operating correctly

Defect Category	Defect in Secondary or Finishing Element
Severity	Minor
Extent	Localised
Recommendation	A further investigation is recommended by the following trades to determine the extent of work required and associated costs. Carpenter
Photos

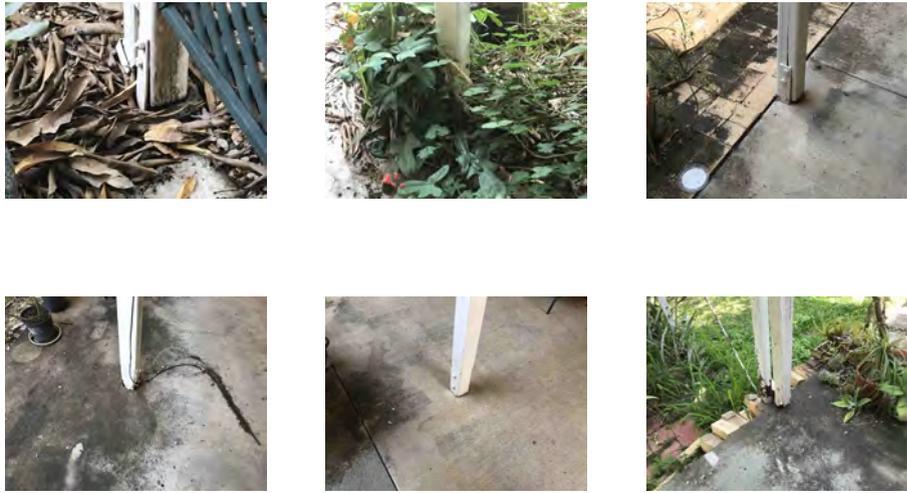
Exterior Platform Defect	
Which Platform	Verandah
Location	At the back
Element	Post
Defect	Timber in contact the ground and damp masonry. Note: Timber should not be in direct contact with the ground or damp masonry and should be seperated by a damp proof barrier or an air space of at least 30mm.
Defect Category	Condition Conducive To Timber Pests
Severity	Moderate - Repairs may involve significant expenditure
Extent	Widespread
Recommendation	Action is required to remove this condition in order to prevent damage to a Structural Element and or Timber Pest activity occuring. A further investigation by the following trades is recommended to determine the extent of work required and associated costs. Carpenter
Photos

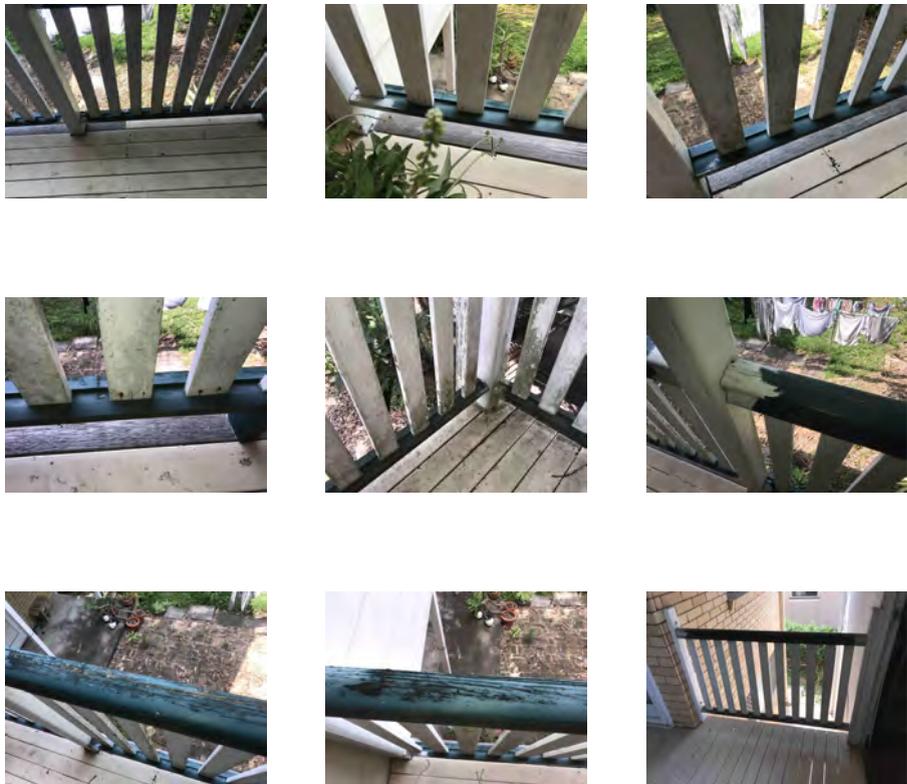
Which Platform	Verandah
Location	At the back
Element	Balustrade Baluster
Defect	<p>Fungal Decay Activity:</p> <p>Indicated by darkening of timber or tide marks.</p> <p>Indicated by visible damage to timber.</p> <p>Indicated by paint discolouration.</p>
Defect Category	Timber Pest Activity
Severity	Moderate - Repairs may involve significant expenditure
Extent	Widespread
Recommendation	<p>Action is required to manage the timber pest. A further investigation by the following trades is recommended to determine the extent of work required and associated costs.</p> <p>Licenced Tradesperson</p>
Photos

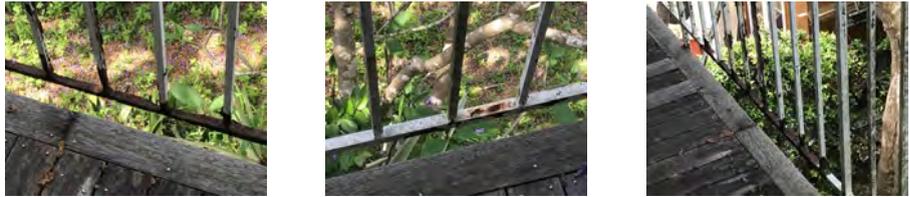
Which Platform	Verandah
Location	At the back
Element	Balustrade
Defect	Corrosion
Defect Category	Defect in Secondary or Finishing Element
Severity	Moderate - Repairs may involve significant expenditure
Extent	Localised
Recommendation	A further investigation is recommended by the following trades to determine the extent of work required and associated costs. Licenced Tradesperson
Photos

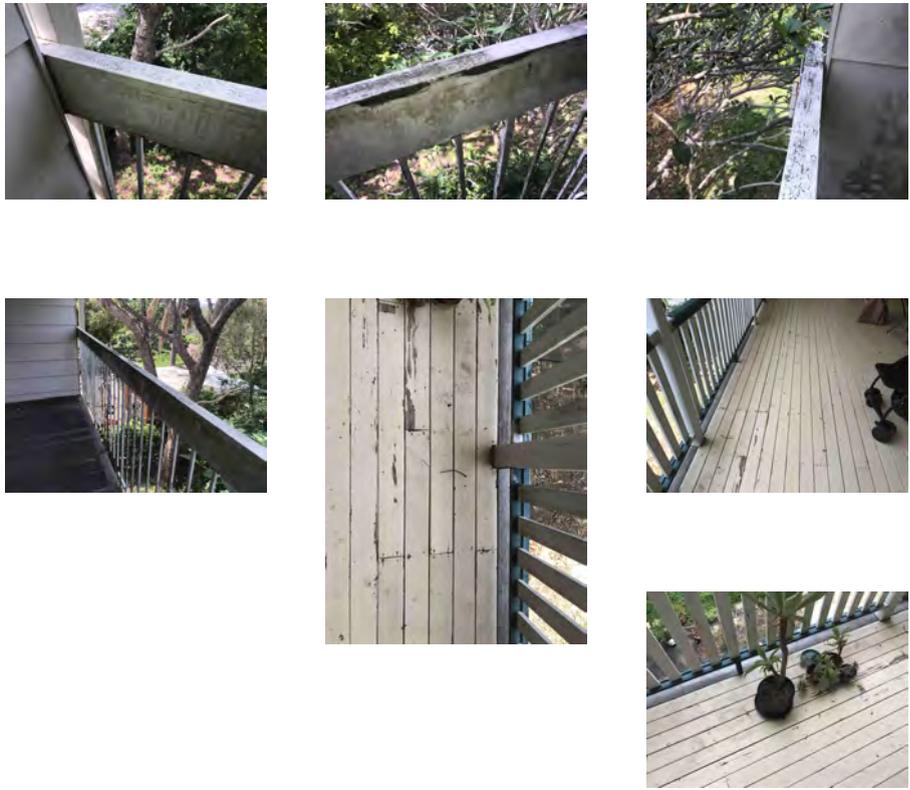
Which Platform	Verandah
Location	At the back
Element	Balustrade Decking
Defect	<u>Fungal Decay Activity:</u> Indicated by paint discolouration.

Defect Category	Timber Pest Activity
Severity	Moderate - Repairs may involve significant expenditure
Extent	Localised
Recommendation	Action is required to manage the timber pest. A further investigation by the following trades is recommended to determine the extent of work required and associated costs. Licenced Tradesperson

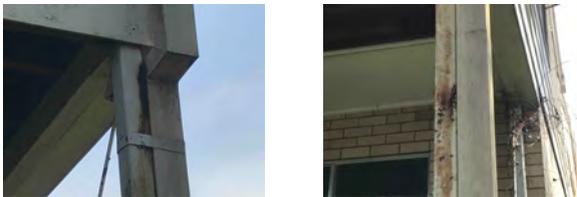
Other Exterior Primary Elements Defect	
Location	At the back

Defect Element	Steel Post
Defect	Corrosion
Defect Category	Defect in Secondary or Finishing Element
Severity	Moderate - Repairs may involve significant expenditure
Extent	Localised
Recommendation	A further investigation is recommended by the following trades to determine the extent of work required and associated costs. Licenced Tradesperson
Photos

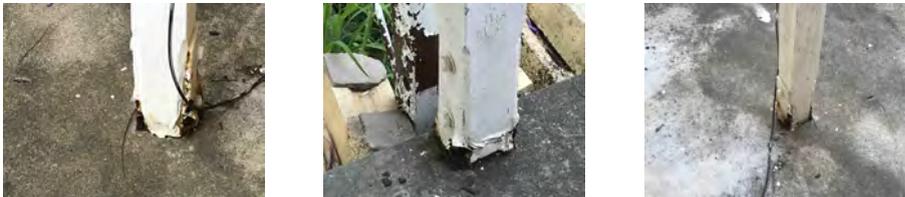
Other Exterior Primary Elements Defect	
Location	At the back
Defect Element	Termite Inspection Zone formed by Metal Stirrup and Air Space
Defect	Corrosion
Defect Category	Defect in Secondary or Finishing Element
Severity	Moderate - Repairs may involve significant expenditure
Extent	Widespread
Recommendation	A further investigation is recommended by the following trades to determine the extent of work required and associated costs. Carpenter
Photos

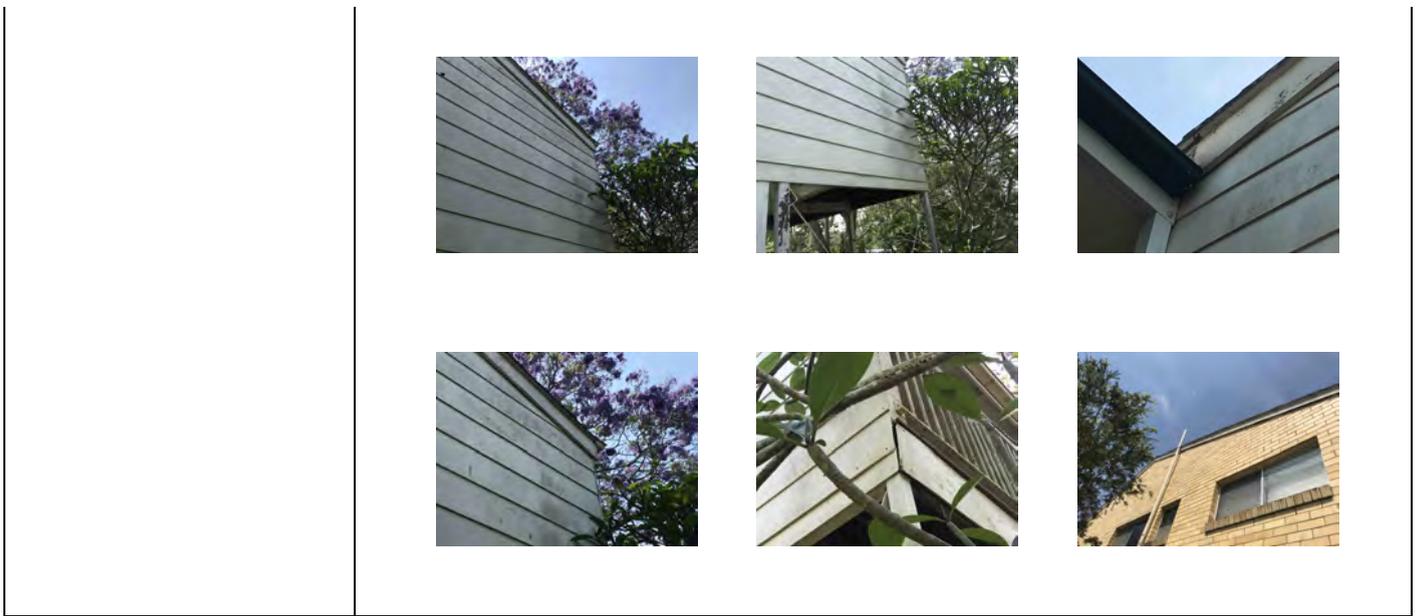
Other Exterior Secondary & Finishing Elements Defect	
Location	In general
Defect Element	Barge board External joinery Cladding
Defect	Fungal Decay Activity: Indicated by paint discolouration. Indicated by visible damage to timber. Indicated by darkening of timber or tide marks.
Defect Category	Timber Pest Activity
Severity	Moderate - Repairs may involve significant expenditure
Extent	The extent was undetermined
Recommendation	Action is required to manage the timber pest. A further investigation by the following trades is recommended to determine the extent of work required and associated costs. Builder and a Pest Controller (Timber Pest Specialist)
Photos

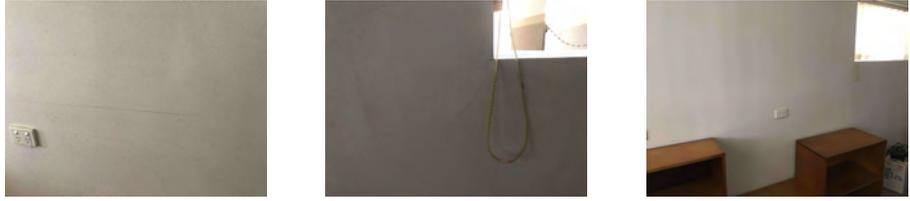
Recommendation	A further investigation is recommended by the following trades to determine the extent of work required and associated costs. Licenced Tradesperson
Photos

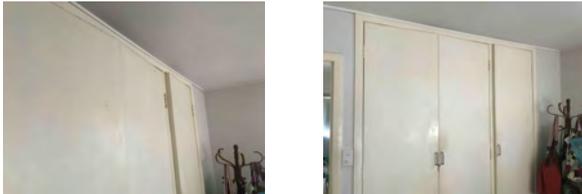
Which Door	Doors to the built-in wardrobe
Location	Bedroom
Element	Door Finish
Defect	Binding
Defect Category	Defect in Secondary or Finishing Element
Severity	Minor
Extent	Localised
Recommendation	A further investigation is recommended by the following trades to determine the extent of work required and associated costs. Carpenter
Photos

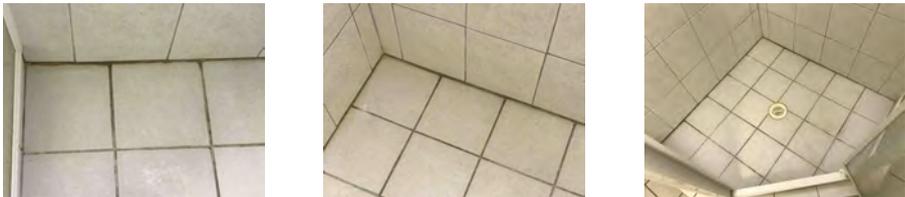
Sanitary Fittings Defect	
Which Fixture	Shower
Location	Ground floor Bathroom
Element	Sealant to shower base perimeter
Defect	Poorly Sealed Maintaining the sealant to splash backs, shower bases, behind tap flanges and the like reduces the pressure on the underlying waterproofing.
Defect Category	Conditions Conducive to Structural Damage & Timber Pest Activity
Severity	Moderate - Repairs may involve significant expenditure
Extent	Localised
Recommendation	This defect falls within the category of Conditions Conducive to Structural Damage & Timber Pest Activity. It is strongly recommended that this condition be removed by resealing.
Photos

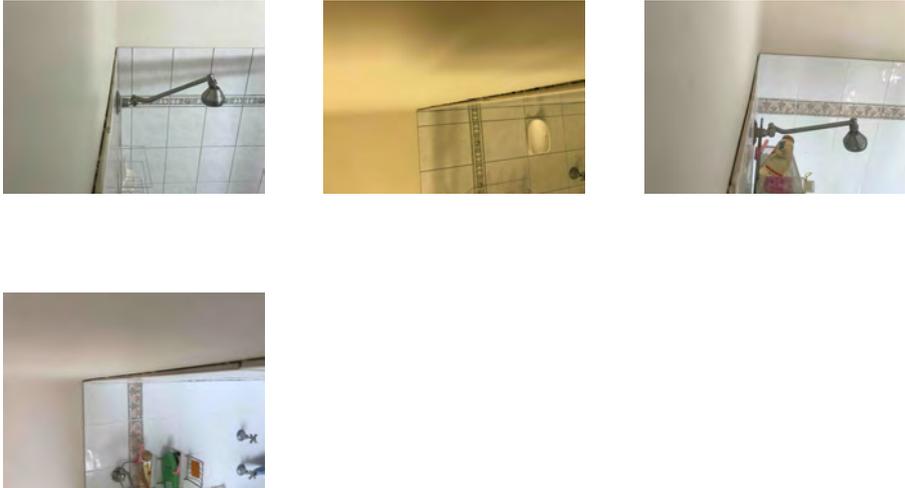
Sanitary Fittings Defect	
Which Fixture	Shower
Location	Bathroom Ensuite
Element	Sealant

Defect	Silicon missing / yet to be installed
Defect Category	Defect in Secondary or Finishing Element
Severity	Minor
Extent	Localised
Recommendation	A further investigation is recommended by the following trades to determine the extent of work required and associated costs. Licenced Tradesperson
Photos

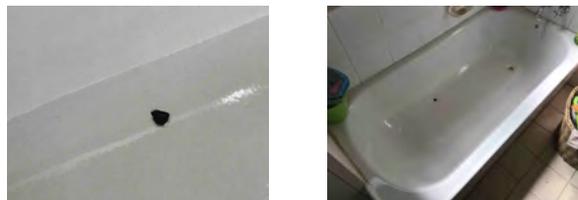
Sanitary Fittings Defect	
Which Fixture	Bath
Location	Bathroom
Element	Bath tub
Defect	Chipped
Defect Category	Defect in Secondary or Finishing Element
Severity	Minor
Extent	Localised
Recommendation	A further investigation is recommended by the following trades to determine the extent of work required and associated costs. Licenced Tradesperson

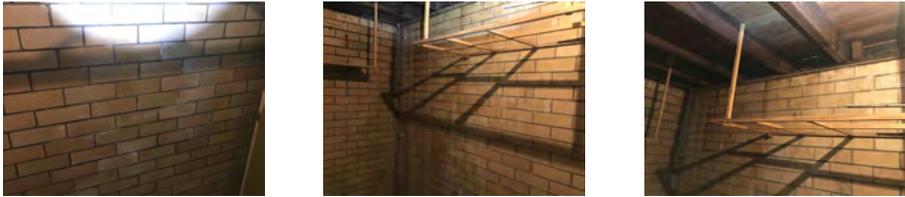
Which Subfloor	Subfloor space to the main building
Area Affected	At the front
Element	Walls
Defect	Moisture penetration consistent with defective or damaged "tanking" (a system of waterproofing to a wall structure partially or fully below ground level)
Defect Category	Condition Conducive to both Structural Damage and Timber Pests
Severity	Moderate - Repairs may involve significant expenditure
Extent	Widespread
Recommendation	Action is required to remove this condition in order to prevent both Structural Damage and Timber Pest activity occurring. A further investigation by a builder is recommended to determine the extent of work required and associated costs.
Photos

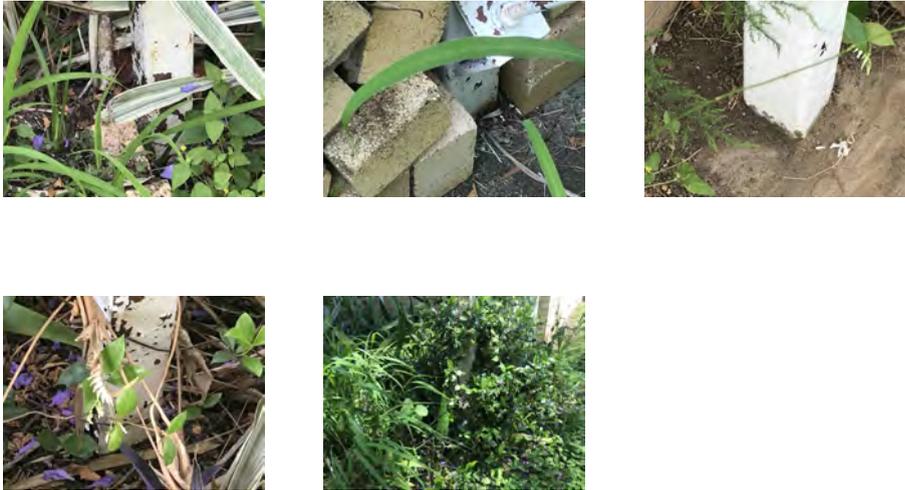
Subfloor Defect	
Which Subfloor	Subfloor space to the main building
Area Affected	At the back
Element	Posts
Defect	Surface rust requireing treatement
Defect Category	Defect in Secondary or Finishing Element
Severity	Minor
Extent	Localised
Recommendation	A further investigation is recommended by the following trades to determine the extent of work required and associated costs. Licenced Tradesperson

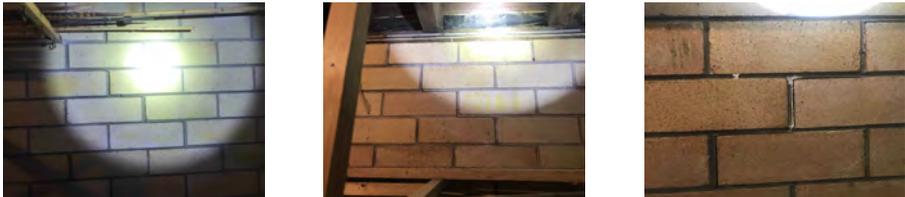
Subfloor Defect			
Which Subfloor	Subfloor space to the main building		
Area Affected	At the front		
Element	Retaining wall		
Defect	Cracking and movement Defects: Diagonal and vertical cracking cause unknown.		
Defect Category	Structural Defect		
Severity	Moderate - Repairs may involve significant expenditure		
Extent	The extent was undetermined		
Recommendation	<p>Action is required to repair the damage to this element to restore structural integrity. A further investigation by the following trades is recommended to determine the extent of work required and associated costs.</p> <p>Geotechnical Engineer</p>		
Photos
