171202

FLOOR TILES. LACK OF MOVEMENT JOINTS

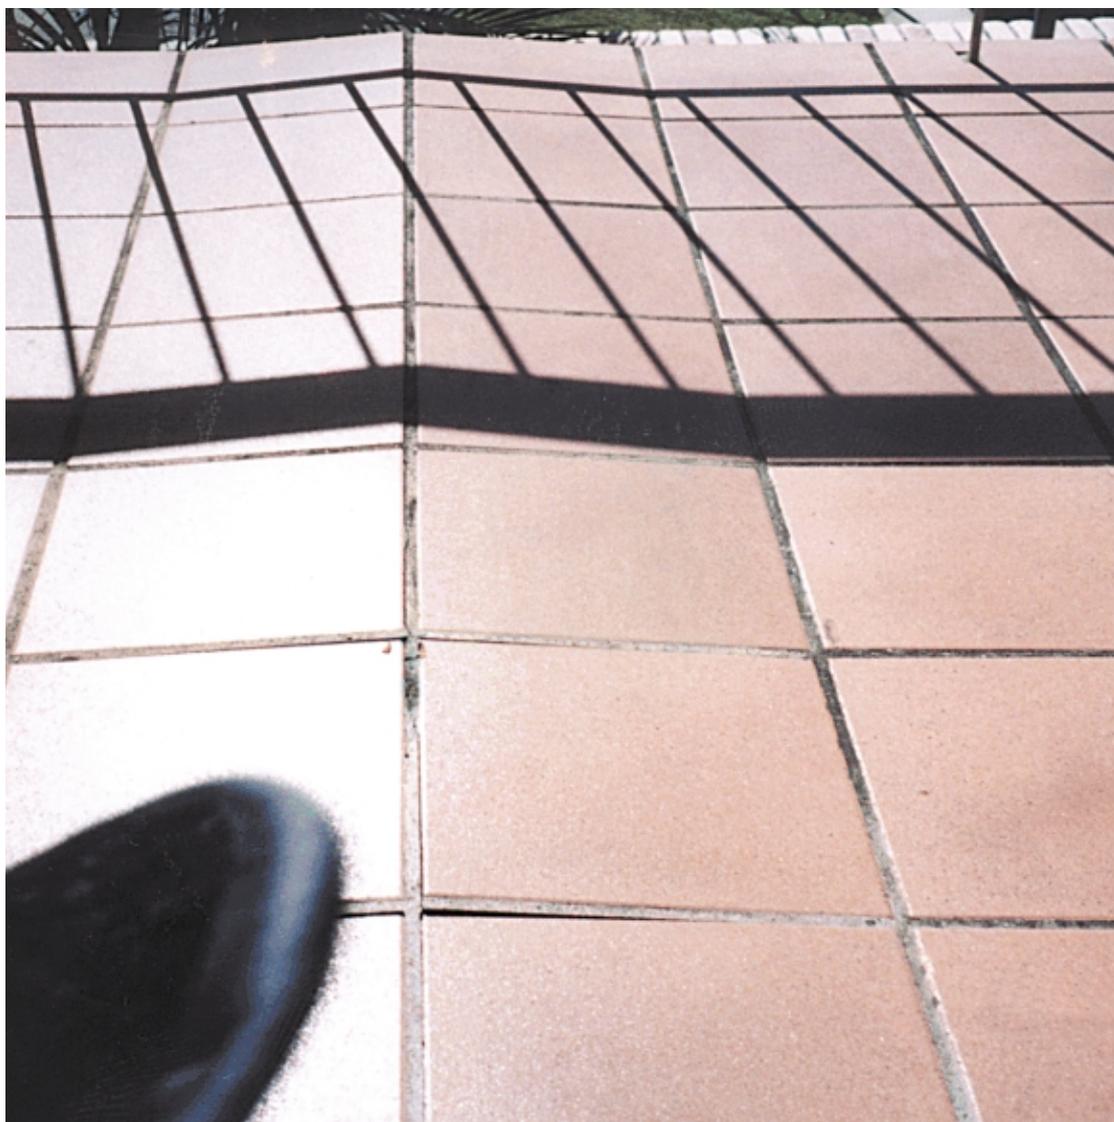
The failure was the lifting of the two rows of tiles by approximately 60mm vertically across the full width of the balcony.

An inspection of the tiled balcony confirmed significant upward movement of two rows of tiles extending across the full width of the first floor external concrete balcony. The balcony was orientated such that it received reasonable amounts of direct sunlight throughout the day.

It was observed that there were no perimeter or intermediate movement joints incorporated in the tile system. The tile system was bound on three sides by brick walls forming the external fabric of the unit complex.

The vertical movement of the tiles presented the occupants with an obvious trip hazard and upon further failure, the exposure of sharp edges with the potential to cause injury.

The primary reason for the failure in this case is attributed to the lack of any perimeter and intermediate movement joints. As the tile system was bound on three sides by brick walls and exposed to temperature differentials there was no ability for release of tensile stresses into compressible movement joints.

- Detaching the tiles from the substrate and reinstalling the entire tile system incorporating perimeter and intermediate (max spacing at 4.5m) movement joints.
