171202

LEAKING SHOWER MEMBRANE FAILURE.

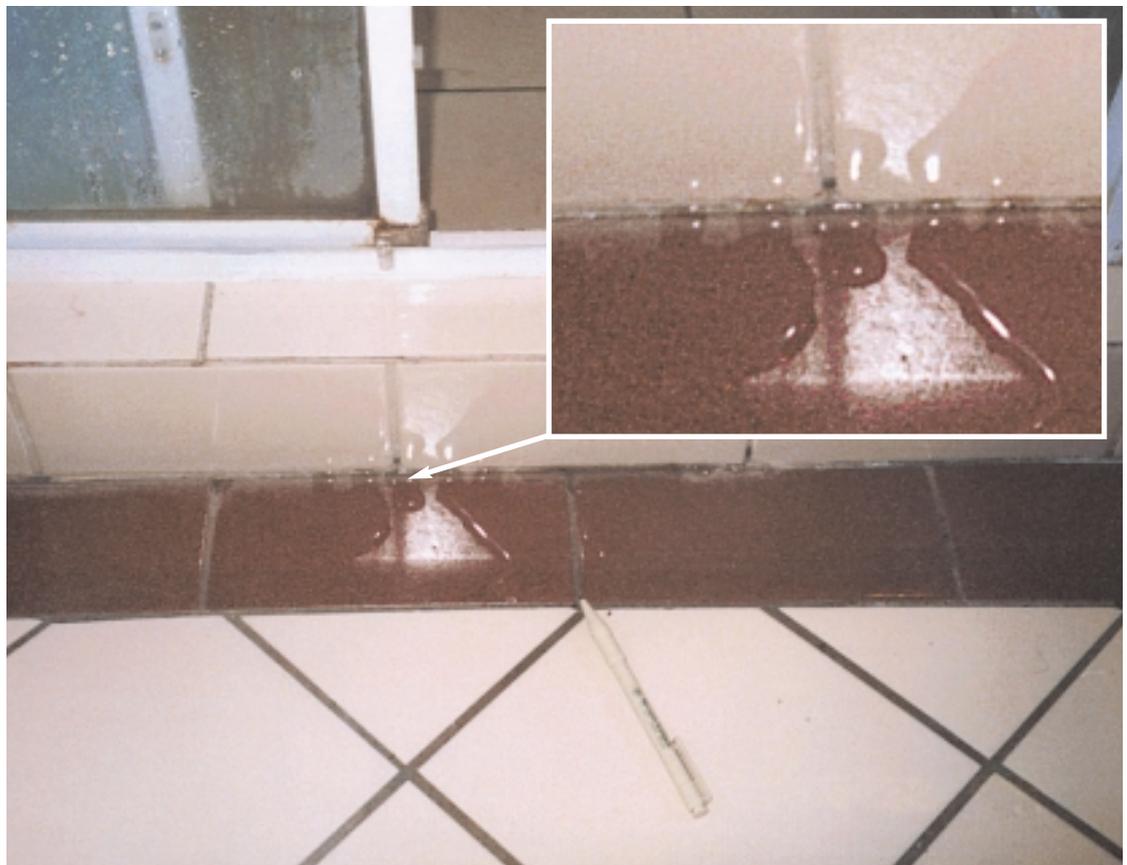
The owners of a slab on ground dwelling noticed, over a period of time, evidence of moisture damage and mould to areas immediately adjacent a screened shower enclosure in their bathroom. The problem became progressively worse to the point where water appeared at the external floor/hob junction 60 seconds after turning on the shower.

The shower base was simply a bedded and tiled recess and formed tiled hob with traditionally fitted framed glass shower screens.

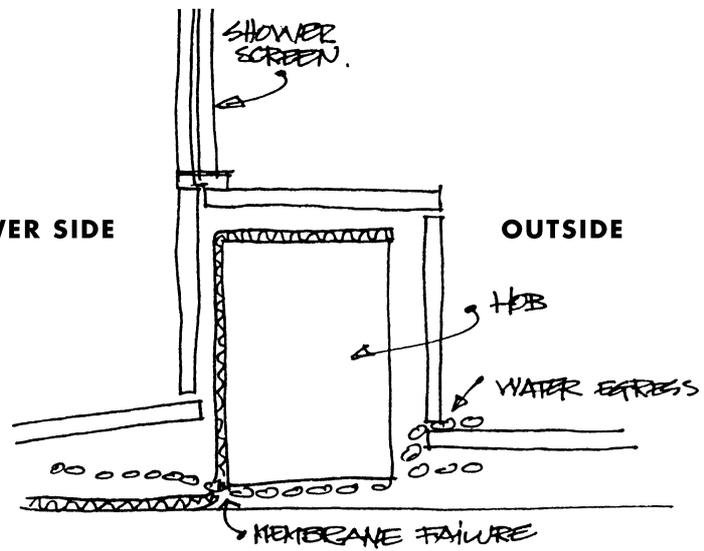
The recessed tray was then tested by sealing the shower waste and flooding the area to a level just below the upper edge of the hob. Within approximately 60 seconds evidence of water migration was visible outside the shower enclosure at the junction of the floor and hob. This migration was found along both elevations of the hob and became

apparent at the wall/floor junctions on the opposite side of the shower recess.

No destructive examination of the shower recess was conducted as the probable cause of the failure was readily apparent. Consequential damage, being swelling of the particleboard gables and base of the vanity unit alongside the shower enclosure, was observed. Significant damage was also observed to the plasterboard sheeting of the broom cupboard. Destructive testing of these areas was conducted to establish the condition of the timber bottom plates and other primary structural elements. In this case the timbers were found to be suitable for continued use.

SHOWER SIDE

OUTSIDE

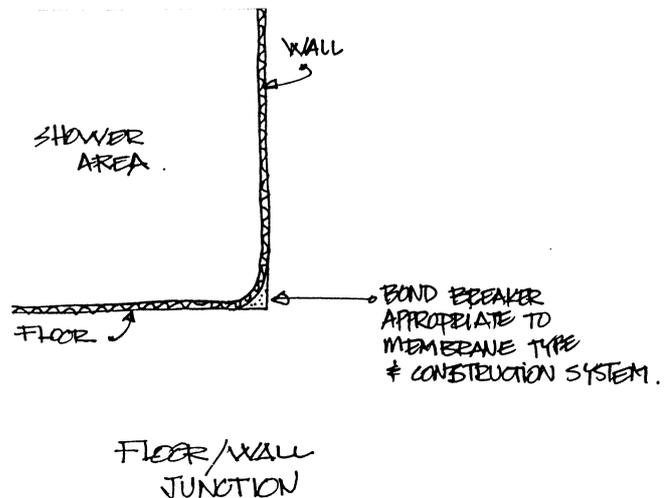
The speed at which the water travelled from within the shower recess to the outside of the hob indicated a massive failure of the waterproof membrane. In this instance complete failure of the membrane at

the internal corner occurred as a result of poor installation and inadequate bond breakers at the horizontal vertical junction.

- Completely removing all the fixtures to the shower area including tap hardware and shower screens
- Completely removing all tiles to the shower base, walls and hob
- Stripping the waterproof membrane and preparing the surface to take a new membrane
- Applying a new membrane to the correct installation standards and re-fitting the shower area
