techninfo

171202

LEAKING SHOWER

TAP FLANGE FAILURE.

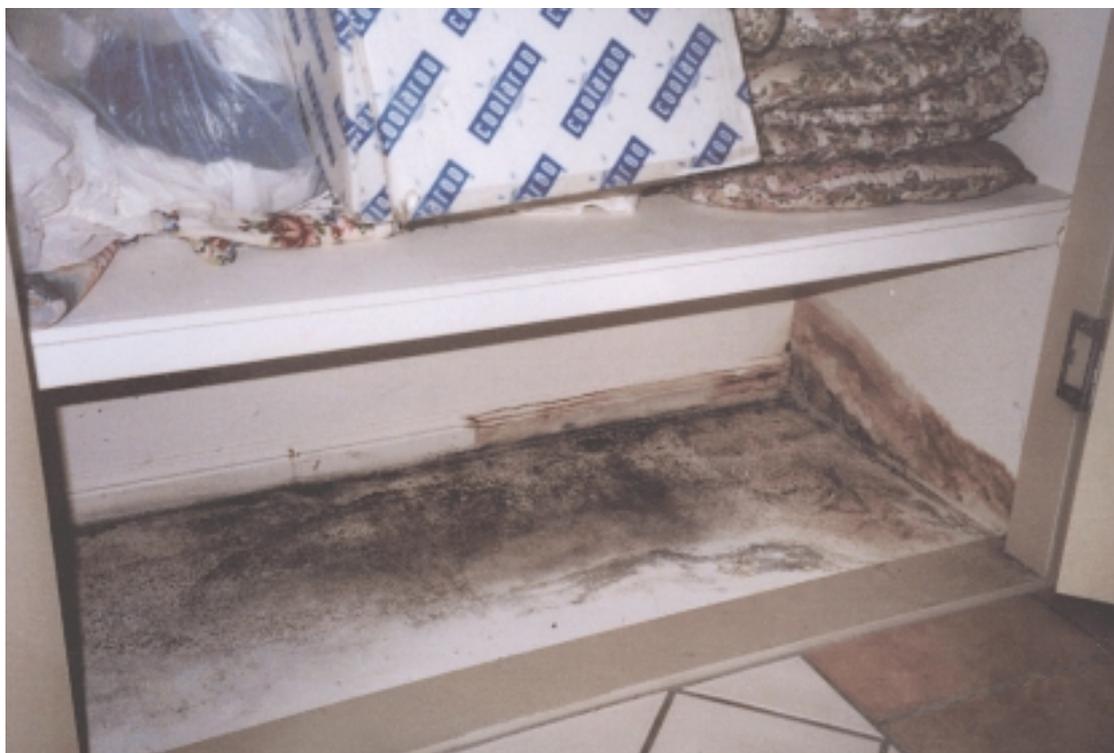
The tenants of a slab on ground dwelling noticed evidence of water staining to the bottom of a cupboard in the hallway. The rear wall of the cupboard was immediately adjacent the main bathroom shower enclosure.

The bottom of the cupboard had carpet covering the slab, which in fact concealed the presence of moisture until it became evident by drawing up the wall sheeting and skirting board.

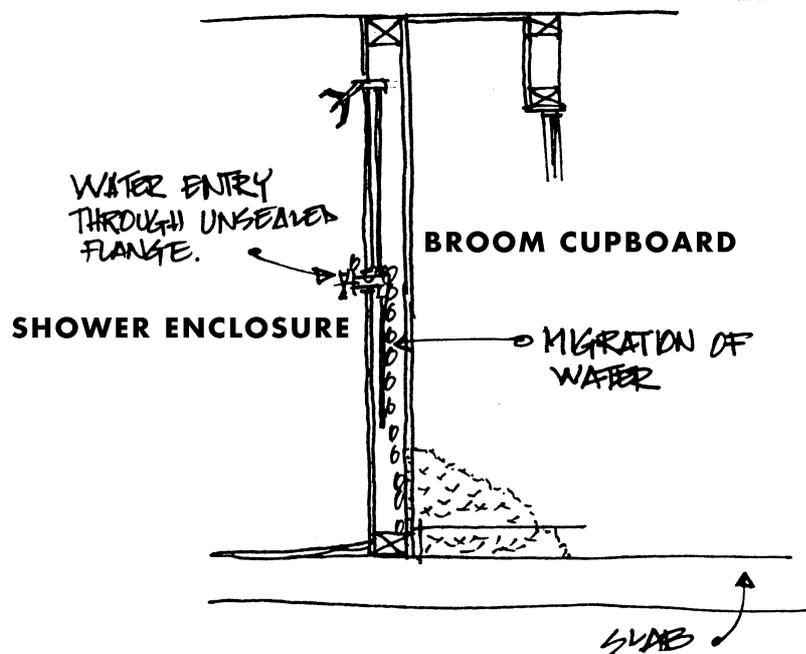
The shower combination was then tested by guiding a stream of water directly at the tap flanges. After ten minutes of test, evidence of water migration became apparent at the wall/floor junction in the adjacent broom cupboard.

The tap flanges were then removed where it was observed that there was no sealant around the body of the tap where it passes through the wall sheeting.

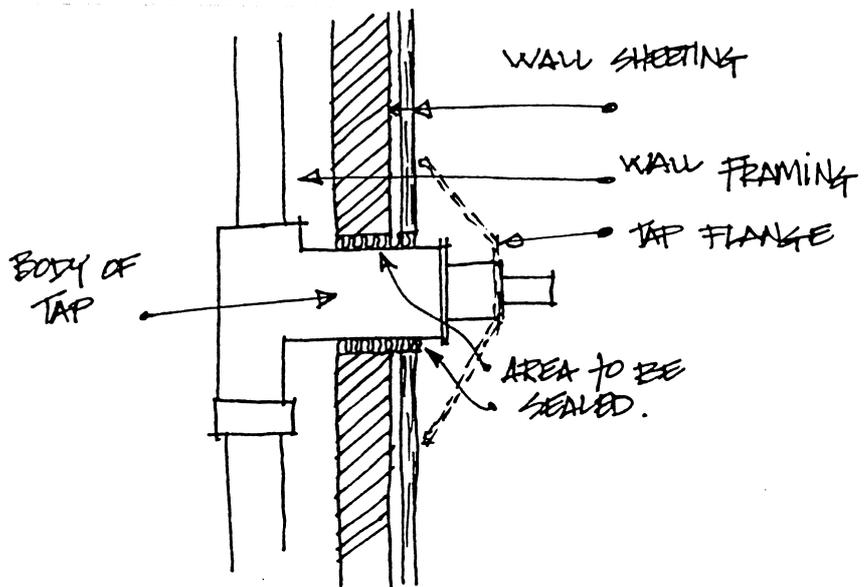
TAP PENETRATION

The primary reason for the water migration into the adjoining cupboard was the lack of sealing at the tap body behind the flange. Water progressively travelled down the cavity of the wall framing until it

reached the concrete slab where it was forced to surface on the outside adjoining wall sheeting.

- Removing the tap flanges and sealing around and between the body of the tap and the wall sheeting.
