techniinfo

111202

WATER STAINS ON PLASTER CEILING

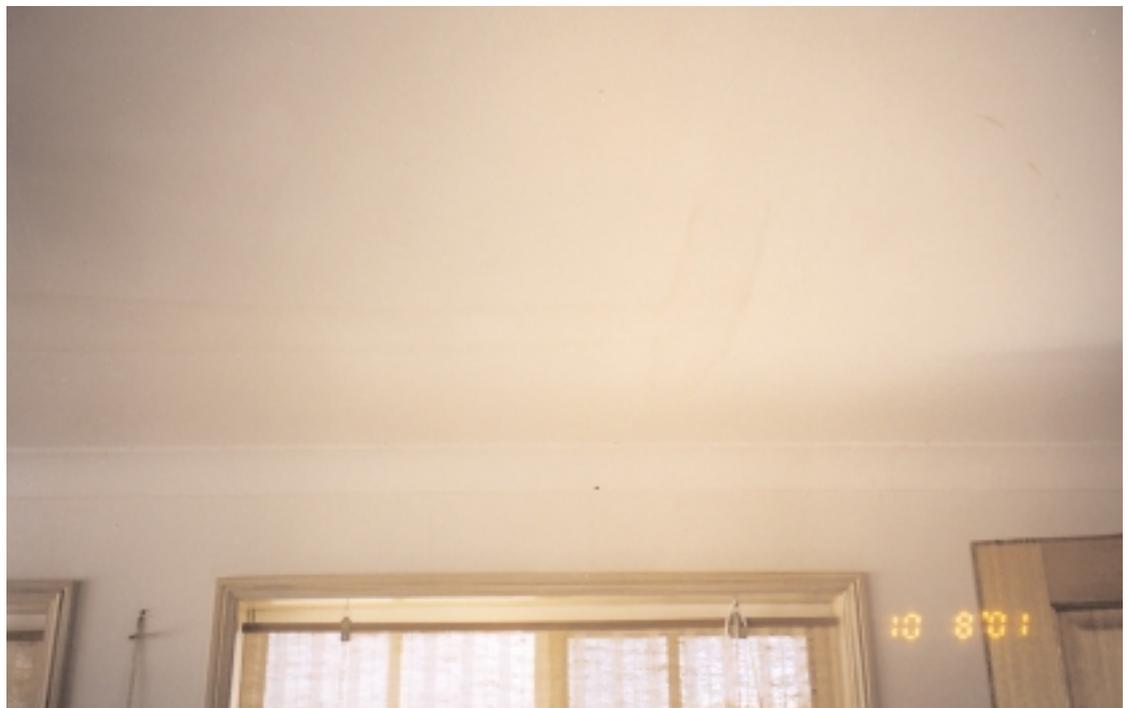
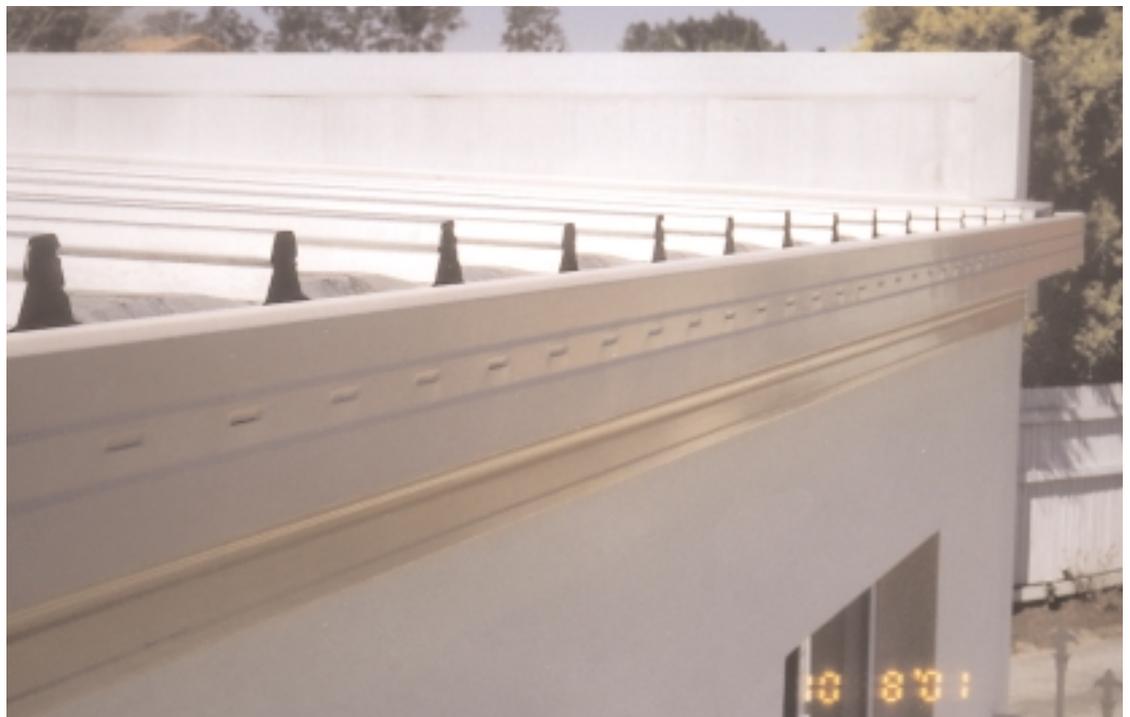
Approximately five years after building completion, water staining appeared on the garage plaster ceiling.

The garage roof is a zincalume klip-lok (tray-deck) style roof, which is fixed to a low-pitched structure. The roof profile is higher than the attached eaves gutter.

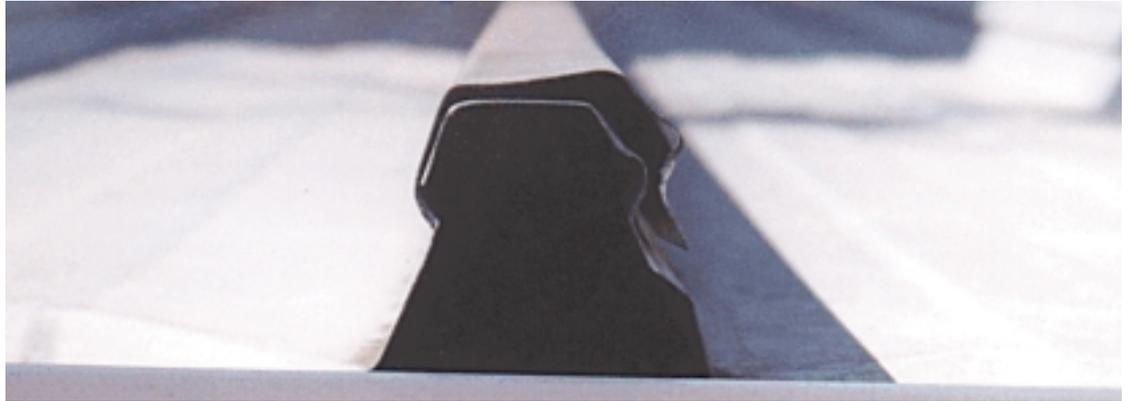
The roof profile is suitable for low-pitched applications such as this designed structure. The deck is secured from beneath and is not pierced;

there are no holes for water to enter. Possible sources for water to enter the ceiling cavity are at flashing intersections and at eaves.

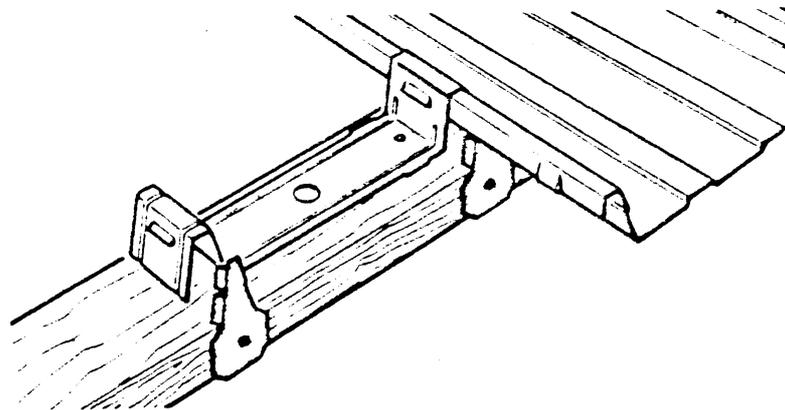
BSA's investigation determined that the installation of the klip-lok deck did not provide for rib-end stops to close the cavities on the underside of the roof sheets.

The rib-end stops can be fitted during the installation by fastening two end stops to the side of the eaves support after the roof sheet has been installed.
