New Construction Handover Report

Property Inspected: Lot 123 Smith Street Kenmore QLD 4300

Inspection Date and Time: Friday 2 February 2000 08:00 AM

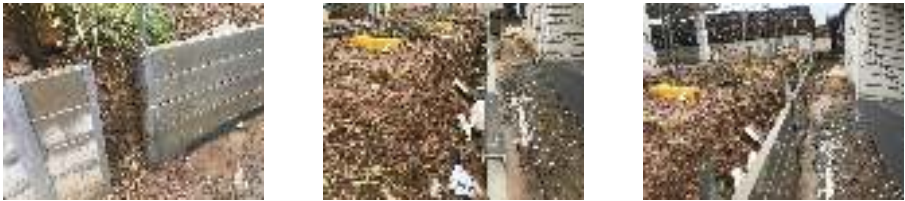
Yard Walls and Fences Defect	
Which Structure	Boundary wall
Location	Northern Side Of The Property
Element	All retaining wall elements
Defect	Incomplete
Defect Category	Defect in Secondary or Finishing Element
Severity	Minor
Extent	Localised
Recommendation	Install missing item. A further investigation by a Builder is recommended to determine the extent of work required and associated costs.
Photos

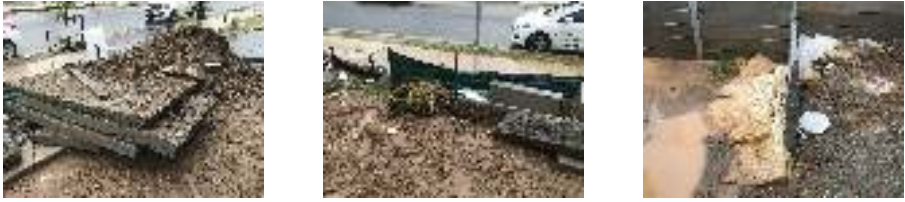
Grounds Defect	
Which Area	Yard
Location	In General
Element	Ground Around The Building
Defect	Defective
Defect Category	Defect in Secondary or Finishing Element

Severity	Minor
Extent	Widespread
Recommendation	Clean
Photos

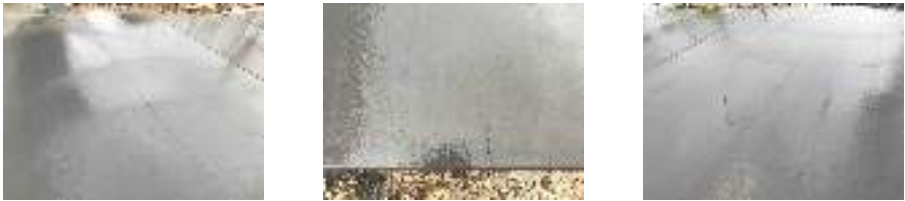
Grounds Defect	
Which Area	Driveway
Location	Southern Side Of The Property
Element	Concrete
Defect	Cracked
Defect Category	Condition Conducive To Structural Damage
Severity	Minor
Extent	Widespread
Recommendation	Action is required to removed this condition in order to prevent damage to a Structural Element occuring. A further investigation by a Builder is also recommended to determine the extent of work required and associated costs.
Photos

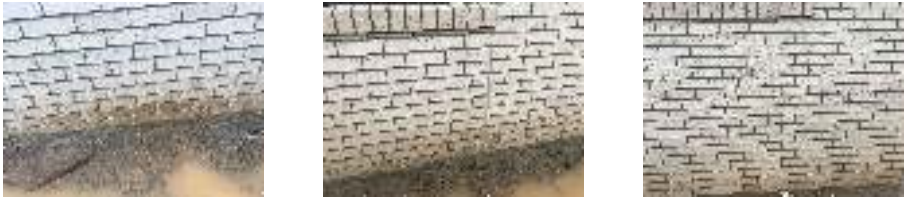
Exterior Walls Defect	
Which Wall	Exterior wall to the main building
Location	In general
Element	Brickwork
Defect	Defective Dirty
Defect Category	Defect in Secondary or Finishing Element
Severity	Minor
Extent	Widespread
Recommendation	Clean
Photos

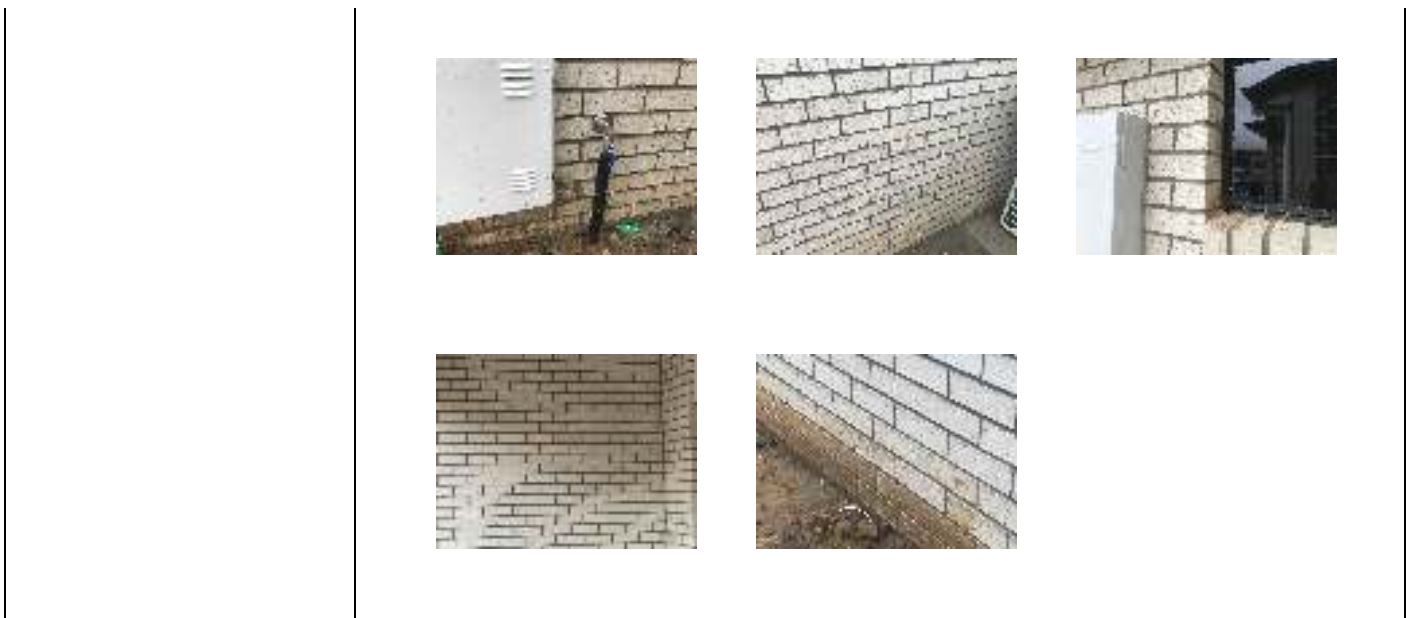
Exterior Walls Defect	
Which Wall	Exterior wall to the main building
Location	Southern side of the building
Element	Render
Defect	Dirty
Defect Category	Defect in Secondary or Finishing Element
Severity	Minor
Extent	Localised
Recommendation	Clean
Photos

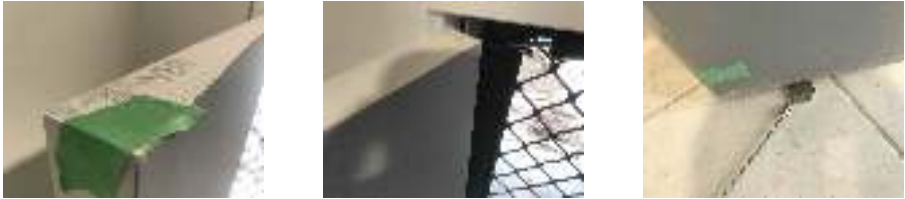
Exterior Door Defect	
Which Door	Front door
Location	At the front Southern side of the building
Element	Door
Defect	Not Painted
Defect Category	Defect in Secondary or Finishing Element
Severity	Minor
Extent	Localised
Recommendation	Paint
Photos

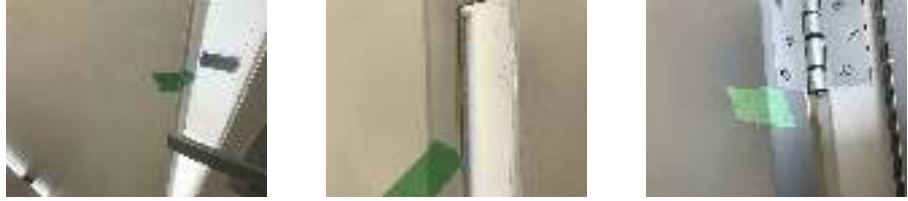
Exterior Door Defect	
Which Door	Front door
Location	At the front Southern side of the building
Element	Door
Defect	Poorly painted
Defect Category	Defect in Secondary or Finishing Element
Severity	Minor
Extent	Localised
Recommendation	Paint
Photos

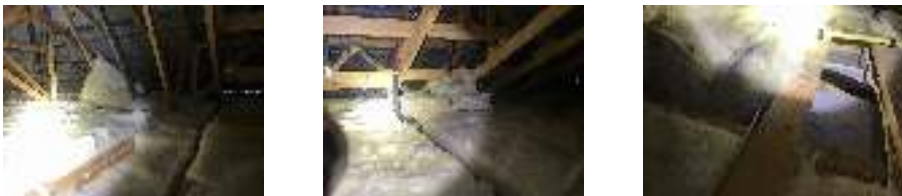
Roof Void Defect	
Which Roof Void	The roof to the garage
Location	In general
Element	Thermal Insulation
Defect	Defective Poorly fitted
Defect Category	Defect in Secondary or Finishing Element
Severity	Minor
Extent	The extent was undetermined
Recommendation	Install missing item.
Notes	Failure to butt all ends and edges of batts to give a snug fit could result losing up to potential insulation benefits. Fit batts snugly between the joists, Ensure batts are fitted with no gaps in accordance with manufactures specification
Photos

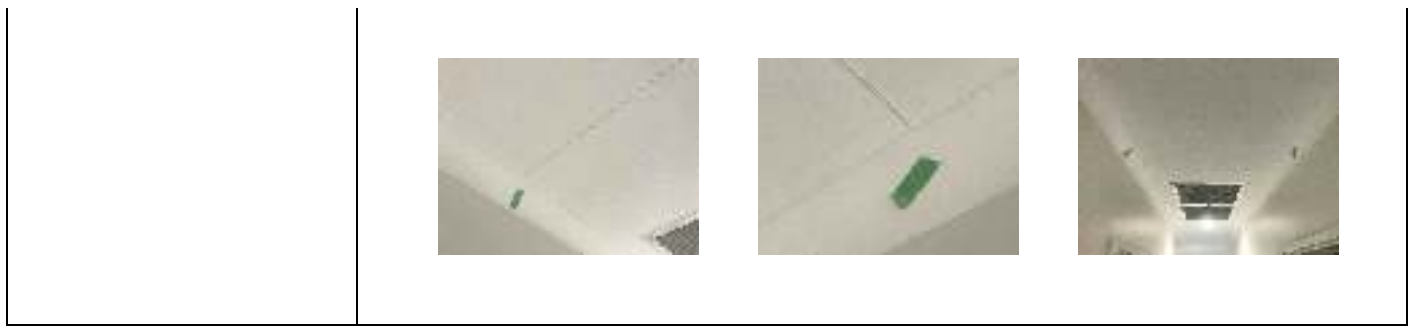
Ceilings And Cornice Defect	
Location	Hallway
Element	Ceiling And Cornice
Defect	Incomplete
Defect Category	Defect in Secondary or Finishing Element
Severity	Minor
Extent	Localised
Recommendation	Install missing item. A further investigation by a Plasterer is recommended to determine the extent of work required and associated costs.
Photos

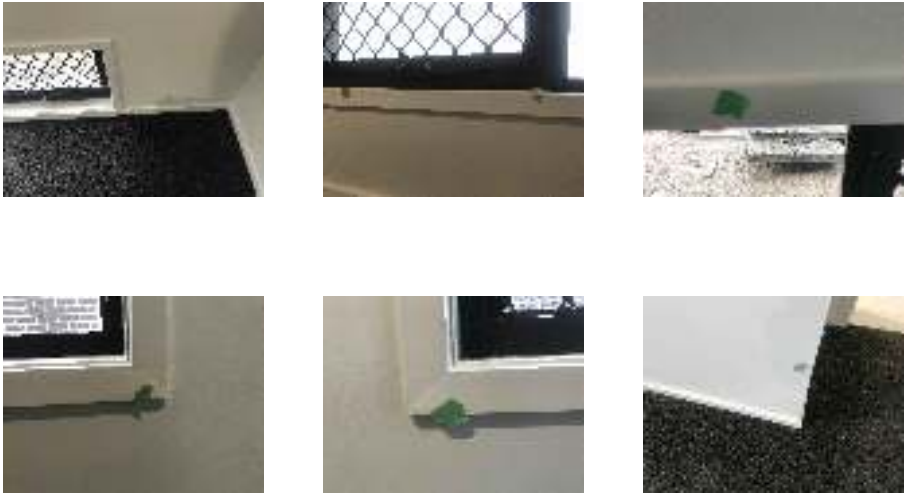
Interior Walls Defect	
Location	Master bedroom
Element	Paintwork
Defect	Minor paintwork imperfections Dents, Marks, Scratches and the like
Defect Category	Defect in Secondary or Finishing Element
Severity	Minor

Extent	Widespread
Recommendation	Paint
Photos

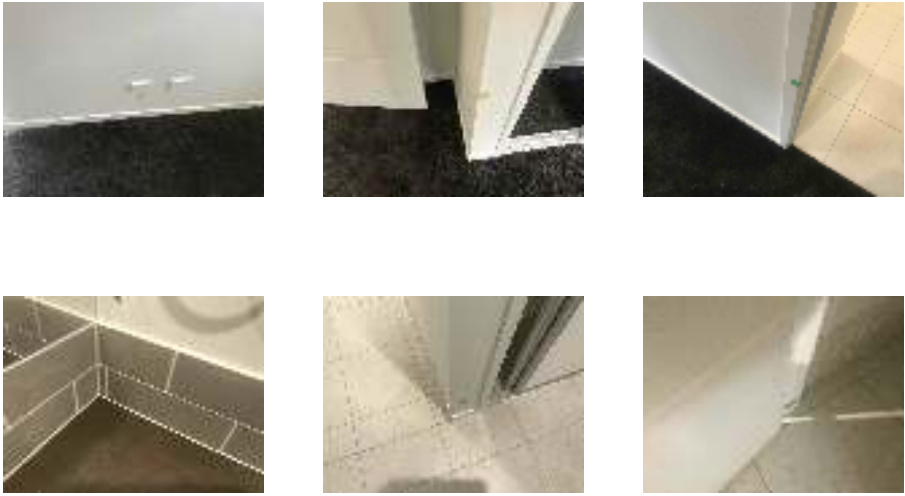
Interior Walls Defect	
Location	In general
Element	Paintwork
Defect	Dents, Marks, Scratches and the like Minor paintwork imperfections
Defect Category	Defect in Secondary or Finishing Element
Severity	Minor
Extent	Widespread
Recommendation	Paint
Photos

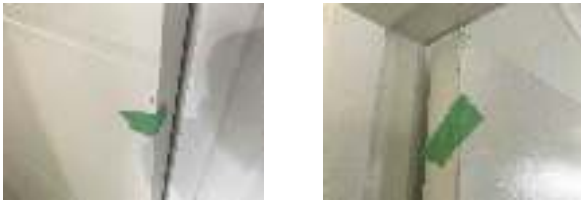
Interior Doors Defect

Which Door	Door
Location	In general Garage Master bedroom Entry level
Element	Door Finish
Defect	Dents, Marks, Scratches and the like Minor paintwork imperfections
Defect Category	Defect in Secondary or Finishing Element
Severity	Minor
Extent	Localised
Recommendation	Paint
Photos

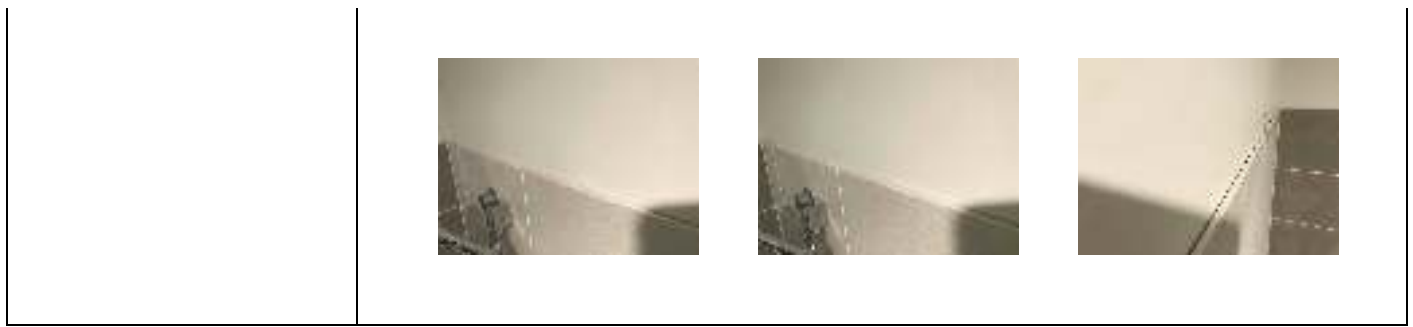
Sanitary Fittings Defect	
Which Fixture	Shower
Location	Master bedroom
Element	Sealant
Defect	Silicon missing / yet to be installed
Defect Category	Defect in Secondary or Finishing Element
Severity	Minor
Extent	Localised
Recommendation	Install missing item. A further investigation by a Tradesperson is recommended to determine the extent of work required and associated costs.
Photos
