091202

## LEAKING SHOWER SCREENS

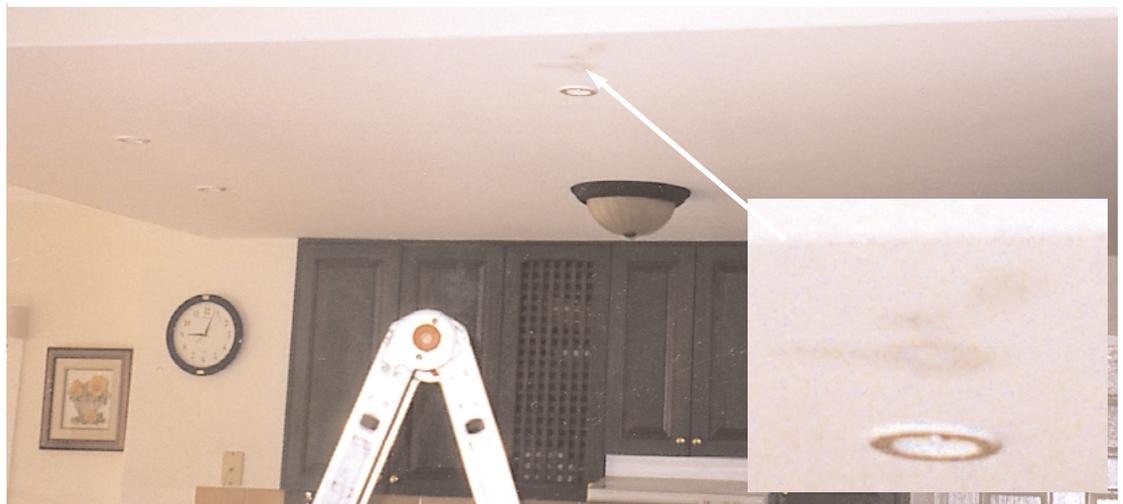
The owners of a two-storey suburban home noticed what appeared to be watermarks on the underside of the ceiling below the main bathroom. The leak was estimated to be in the area immediately below the shower tray.

The staining on the ceiling was detected at an early stage and probably prevented the long-term exposure of timber flooring members to the effects of moisture. The owners expressed great concern about the proximity of the staining and down-lights in the ceiling. Evidence of water entry into the actual light fittings was obvious.

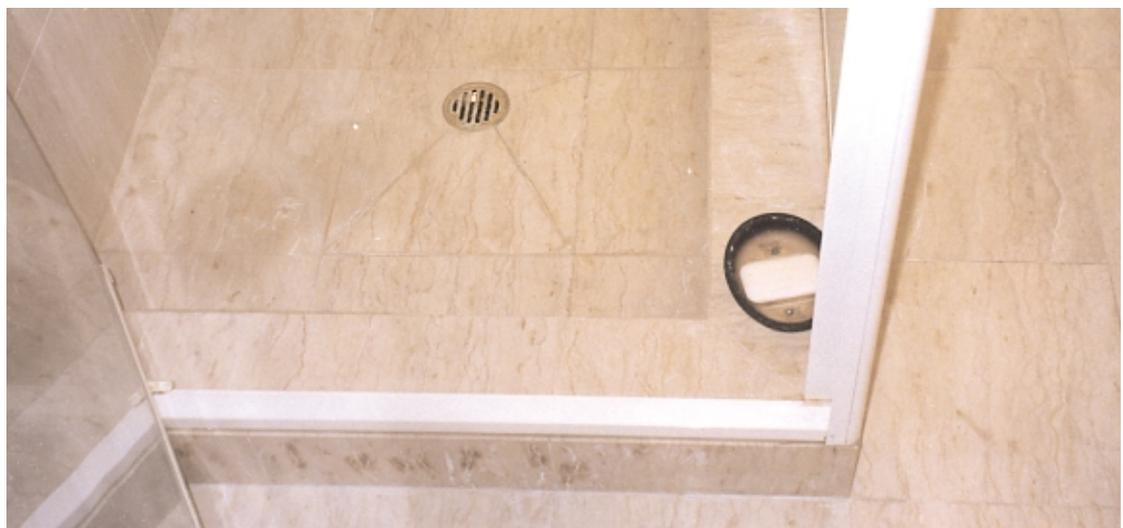
concentrate the shower nozzle at the hob/screen junction to simulate the flow of water during use. After approximately 10 to 15 minutes of water flow, the area of staining was observed to become noticeably moist.

As the shower screen was located on the outside edge of the formed hob, it was decided to

Water was also observed to pass between the bottom edge of the shower screen door and the top edge of the tiled hob. This was considered to also be indicative of the normal use of the shower.

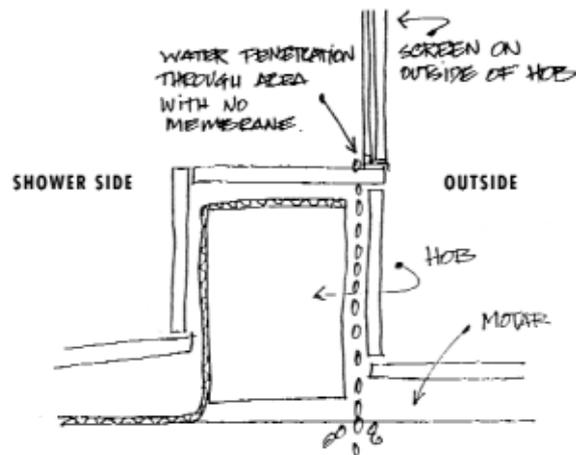
- The water was found to be tracking through the inside face of the tile on the outer edge of the hob and the hob itself.
- There was no indication of a waterproof membrane at this location.
- Water migrated through the flooring members and became evident on the outside face of the plasterboard ceiling.

SHOWER SCREEN LOCATION - OUTSIDE EDGE OF HOB.

- Removing the shower screen from the top of the hob
- Re-tiling and repairing the waterproofing membrane where required
- Relocating and sealing the shower screen to the inside edge of the hob
- Providing (as a precautionary measure) a hinged flexible flap to the bottom of the shower screen door to restrict water flow to the outside of shower enclosure.

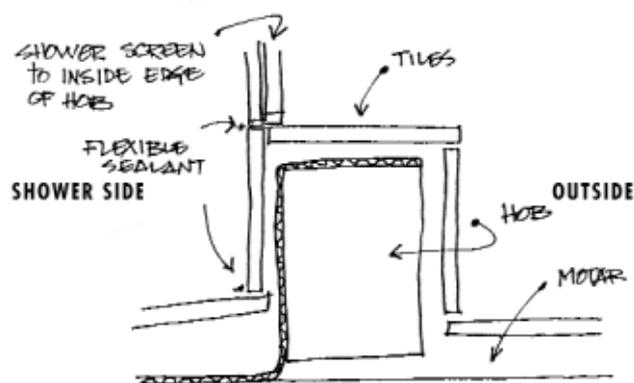
SHOWER SCREEN LOCATION - INSIDE EDGE OF HOB.

The corrective measure of moving and properly sealing the shower screen to the inside edge of the hob brought the enclosure into conformity with the requirements of Australian Standard 3740 – Waterproofing of wet areas within residential buildings.
